COLORADO CULTURAL RESOURCE SURVEY

Architectural Inventory Form

- 1. Resource number: **5SM.1739**
- 2. Temporary resource number: **N/A**
- 3. County: **San Miguel**
- 4. City: **Telluride**
- 5. Historic Building Name: **Unknown**
- 6. Current Building Name: **Cottage Properties LLC House**
- 7. Building Address: **512 W. Galena Avenue**
- 8. Owner Name and Address: **Cottage Properties LLC
564 Warren Street
Needham, MA 02492**

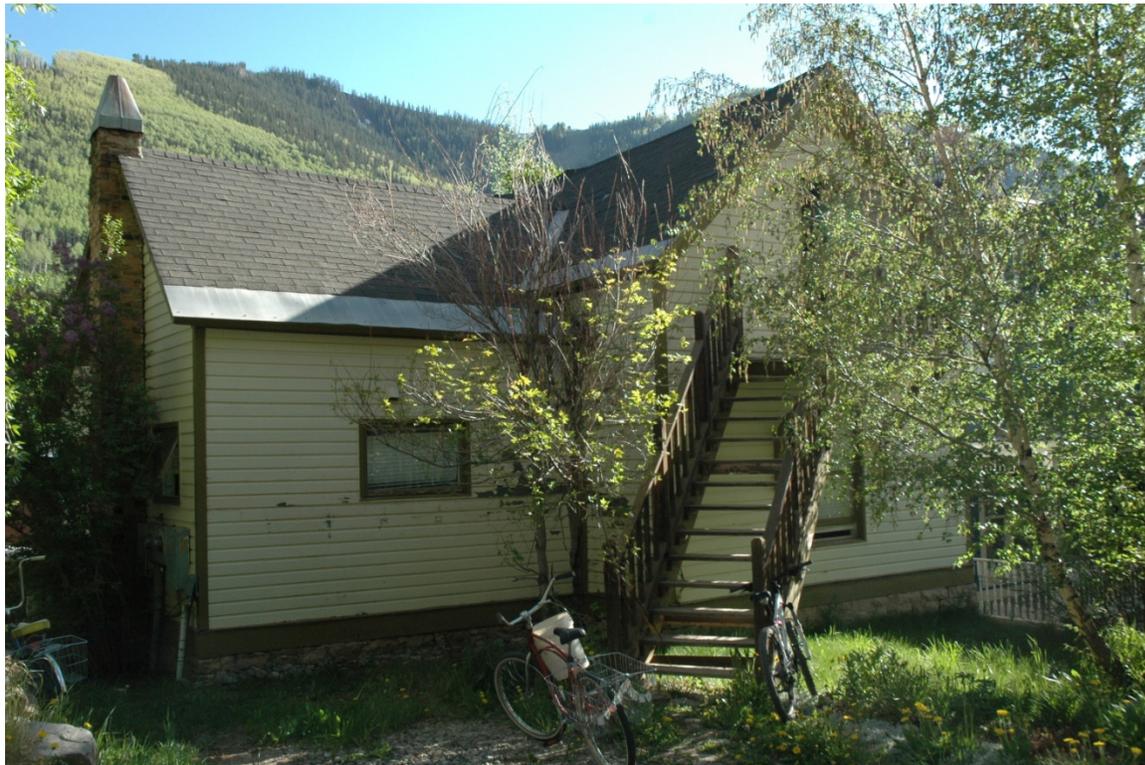
21. General architectural description:
This is a 1½-story, cross gabled, L-shaped dwelling of wood frame construction. The west (front gabled) wing measures 28½' N-S by 16' E-W. The west (side gabled) wing measures 23½' N-S by 14' E-W. The house is supported by a low unpainted coursed sandstone foundation, while its exterior walls are clad with painted cream yellow horizontal weatherboard siding with painted copper color 1" by 4" corner boards. The cross gabled roof is covered with black asphalt composition shingles, and the eaves are boxed with painted copper color wood trim. A non-historic red brick fireplace chimney is on the east elevation. A painted copper color wood-paneled front door, with one upper sash light, enters the upper gable end on the north elevation. This door is accessed by a non-historic, angled, exterior wooden staircase in the front yard. A gabled upper half story addition to the west end of the south (rear) elevation dates to the early 1980s. The addition features a gabled wall dormer, with a 1/1 double-hung sash window, on the west elevation, and a gabled dormer on the east elevation. A set of paired glass-in-wood-frame doors open from the upper half story onto a balcony on the south elevation. Another set of paired glass-in-wood frame doors enter the main level on the south elevation from a wood deck. Many of the home's windows were altered in the early 1980s. Windows include double-hung sash, single-light fixed-panes and awning types..
