COLORADO CULTURAL RESOURCE SURVEY

Architectural Inventory Form

- 1. Resource number: **5SM.1824/THAS.91**
- 2. Temporary resource number: **N/A**
- 3. County: **San Miguel**
- 4. City: **Telluride**
- 5. Historic Building Name: **Unknown**
- 6. Current Building Name: **Nelson House**
- 7. Building Address: **101 E. Gregory Avenue**
- 8. Owner Name and Address: **F. William and Susan J. Nelson
155 N. Roosevelt
Wichita, KS 67208**

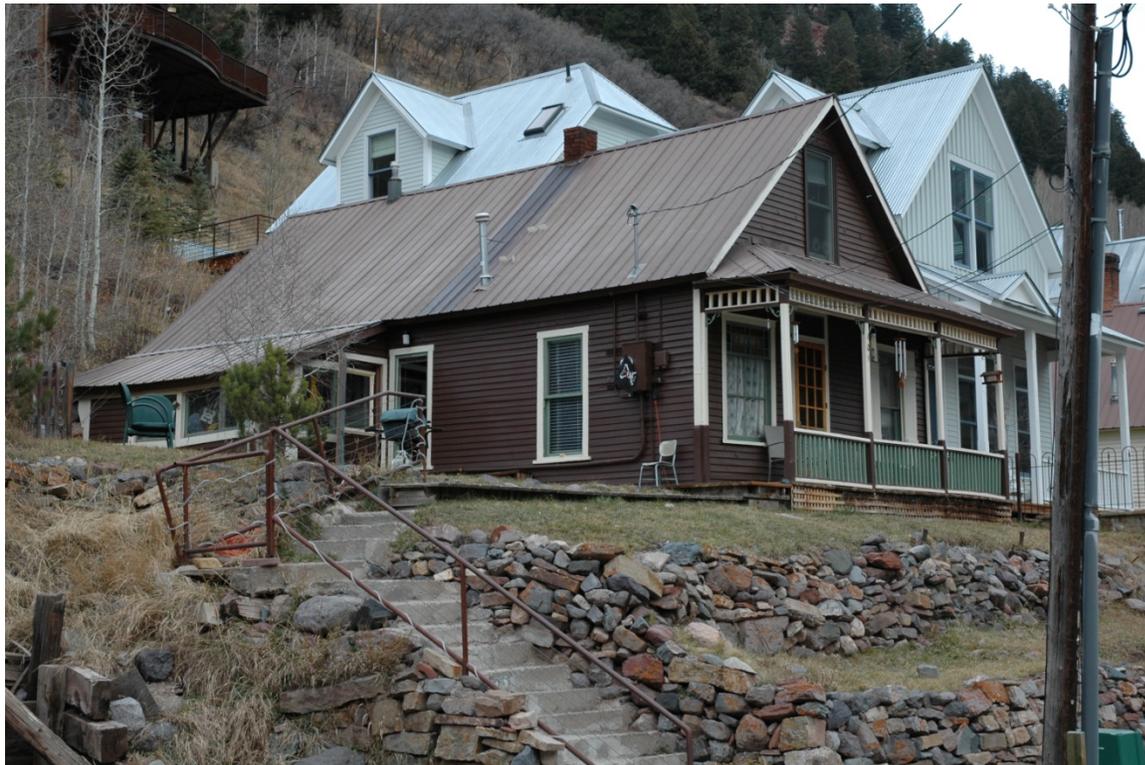
21. General architectural description:
This is a 1½-story, rectangular-shaped, wood frame dwelling, with an open front porch on the south elevation, and an enclosed shed-roofed rear porch at the north end of the west elevation. The main 1½-story front gabled section measures 34½' N-S (deep) by 20½' E-W (across); the open front porch measures 4½' N-S by 20½' E-W; the enclosed shed-roofed rear porch measures 16' N-S by 6' E-W. The dwelling's north (rear) elevation is built into the hillside which rises sharply above Gregory Avenue. The house is supported by a low poured concrete foundation, and its exterior walls are clad with painted brown horizontal wood siding with painted cream white 1" by 4" corner boards. The front gabled roof is steeply-pitched, with metal roofing material and painted brown boxed eaves. A red brick chimney is on the ridge. The house's nearly symmetrical facade overlooks Gregory Avenue on the south elevation. A painted or stained brown wood-paneled front door, with one upper sash light and a leaded glass transom light, is covered by a 15-light stained natural brown glass-in-wood-frame storm door. This door enters the facade from the open front porch. The porch features a wood plank floor, a painted green and white open wood railing, painted white and brown chamfered wood posts with delicate brackets, a painted white and brown wood frieze, and a low-pitched hipped roof. A painted brown and cream white wood-paneled door, covered by a painted green wood screen door, enters the enclosed shed-roofed rear porch at the north end of the west elevation. The home's windows predominantly have painted green wood frames and painted cream white wood surrounds. A distinctive single-hung sash window, with stained glass upper sash lights and four lower sash lights, overlooks the front porch west of the front door. A 1/1 double-hung sash window, with functional painted white wood shutters, overlooks the front porch east of the front door. A 1/1 double-hung sash

window penetrates the facade's upper gable end. Windows on the secondary elevations are also 1/1 double-hung sash, except for a 1x1 horizontal sliding window which penetrates the west wall of the enclosed rear porch.
