COLORADO CULTURAL RESOURCE SURVEY

Architectural Inventory Form

- 1. Resource number: **5SM.1822/THAS114**
- 2. Temporary resource number: **N/A**
- 3. County: **San Miguel**
- 4. City: **Telluride**
- 5. Historic Building Name: **N/A**
- 6. Current Building Name: **Hickcox House**
- 7. Building Address: **119 E. Gregory Avenue**
- 8. Owner Name and Address: **Gary and Jane L. Hickcox  
P. O. Box 994  
Telluride, CO 814350994**

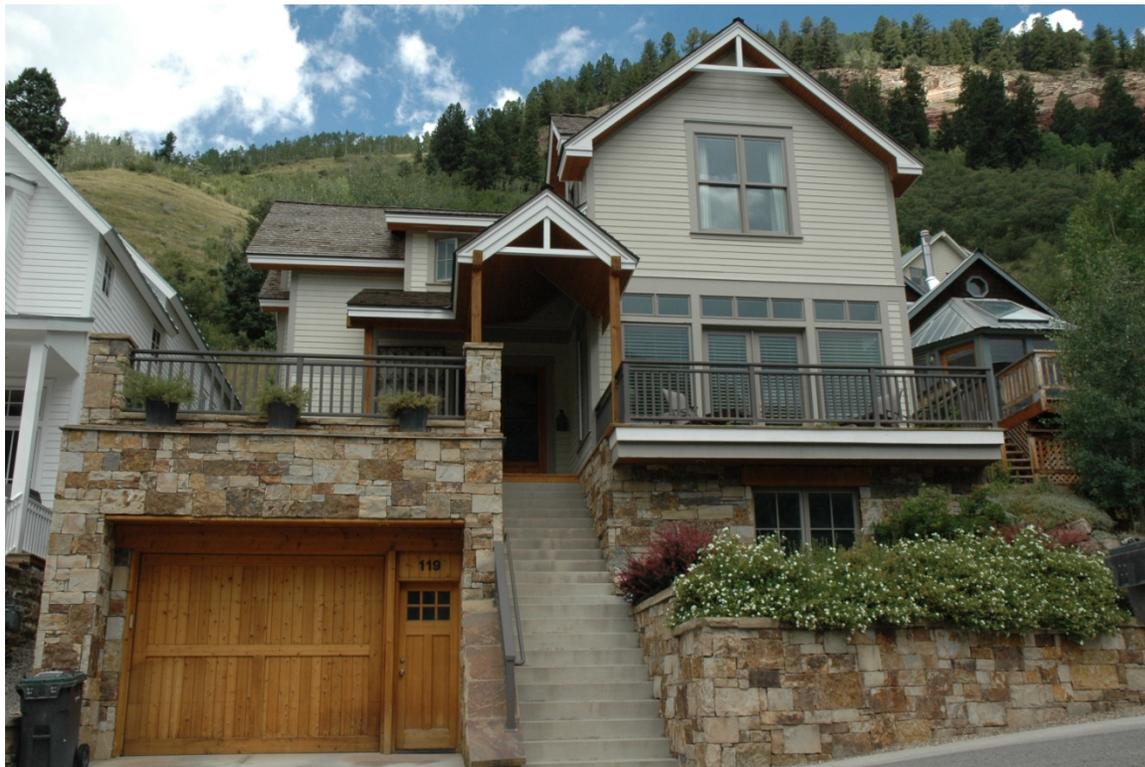
<b>THLD RATING:</b>	<b>Primary – Non-Designated – New Construction Shed – Non-contributing without Qualifications</b>
---------------------	---

21. General architectural description:  
**This is a tall 1½-story wood frame residence with an attached garage and walkout basement level on the south elevation which faces onto Gregory Avenue. The house rests on a poured concrete foundation, faced with a stone veneer. The exterior walls are painted pale grey horizontal wood siding, with painted dark grey 1" by 4" corner boards. The roof is a moderately-pitched cross gable, with wood shingles and boxed eaves finished with stained brown bead board and painted white wood trim. A shed-roofed dormer, with a band of four 4-light windows, is on the south-facing roof slope. A gable ornament is in the facade's upper gable end on the south elevation. Windows are predominantly paired 1/1 double-hung sash and single and paired 4-light windows. A long flight of 22 concrete steps ascend from Gregory Avenue to the front porch on the south elevation. A stained brown wood-paneled front door, with a long upper sash light, leads into the house from the porch which is covered by a gable roof supported by stained brown 6" by 6" wood posts. A set of paired glass-in-wood-frame atrium doors, with flanking side lights and transom lights, opens onto an elevated deck above the walkout basement level at the east end of the south elevation. A stained brown overhead garage door and a wood-paneled door with six upper sash lights enter the garage at street level at the west end of the south elevation. A shed-roofed rear porch is on the north elevation.**
