COLORADO CULTURAL RESOURCE SURVEY

Architectural Inventory Form

- 1. Resource number: **5SM.1825**
- 2. Temporary resource number: **N/A**
- 3. County: **San Miguel**
- 4. City: **Telluride**
- 5. Historic Building Name: **Unknown**
- 6. Current Building Name: **Paak House**
- 7. Building Address: **129. W. Gregory Avenue**
- 8. Owner Name and Address: **Paak Family Limited Partnership  
2006 Eastlawn Avenue  
Durango, CO 81301**

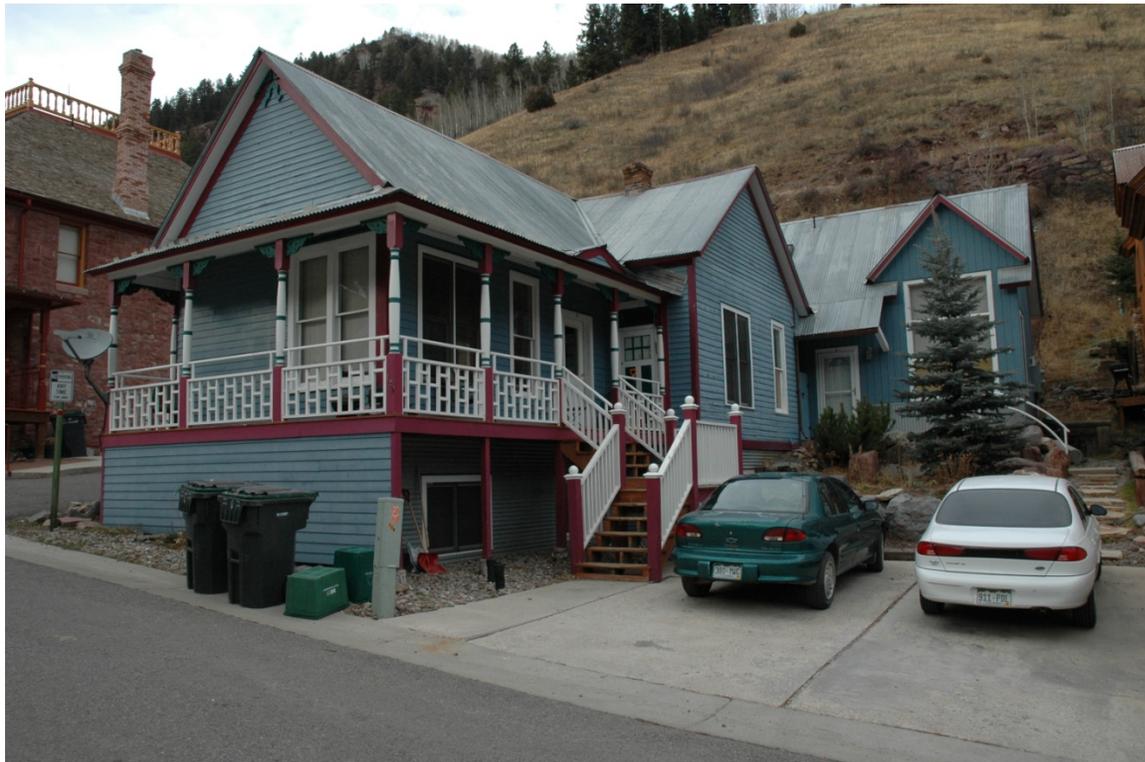
**This residence is composed of an original (circa 1900) L-shaped, cross gabled dwelling, and a rectangular-shaped cross gabled (2002) addition to the north (rear) elevation. The original house's south, front-gabled, wing measures 20' N-S by 45' E-W, while its short side-gabled wing to the east measures 25' N-S by 6' E-W. The 2002 rear addition measures 22' N-S by 39' E-W. The house is built into the hillside, thus the poured concrete foundation ranges in height from six feet above grade on the south elevation to at grade on the north elevation. The basement level foundation wall at the south end is clad with corrugated metal and penetrated by 1x1 horizontal sliding egress windows. The exterior walls are clad with painted blue horizontal wood siding, with painted burgundy 1" by 4" corner boards. A gable ornament is in the south elevation's upper gable end. The roof is covered with corrugated metal, and the eaves are boxed with painted burgundy and light blue wood trim. A red brick chimney is on the ridge. The home's windows are entirely single and paired 1/1 double-hung sash, with painted white wood frames and surrounds, except for a single-light bathroom window on the west elevation. Two wood-paneled doors enter the east elevation from an open L-shaped porch which covers all of the south elevation and the south end of the east elevation. One of these doors is painted white with one upper sash light, while the other is painted green and white with nine upper sash lights. Ten wooden steps approach the east side of the porch which features a wood plank floor, a painted white open wood railing, painted white and burgundy turned columns, painted green pierced brackets, and a low-pitched hipped roof. The addition's walls are clad with painted light blue vertical wood siding. A painted white wood-paneled door, with a fanlight, and covered by a metal storm door, enters the addition's south elevation where it extends past the east wall of the original dwelling.**
