COLORADO CULTURAL RESOURCE SURVEY

Architectural Inventory Form

- Determined Eligible – National Register
- Determined Not Eligible – National Register
- Determined Eligible – State Register
- Determine Not Eligible – State Register
- Need Data
- Contributes to eligible National Register District
- Noncontributing to eligible National Register District

- 1. Resource number: **5SM.1821**
- 2. Temporary resource number: **N/A**
- 3. County: **San Miguel**
- 4. City: **Telluride**
- 5. Historic Building Name: **Unknown**
- 6. Current Building Name: **Hansen House**
- 7. Building Address: **131 (139) E. Gregory Avenue**
- 8. Owner Name and Address: **Richard W. and Joanne B. Hansen  
2S502 Heaton Drive  
Batavia, IL 60510**

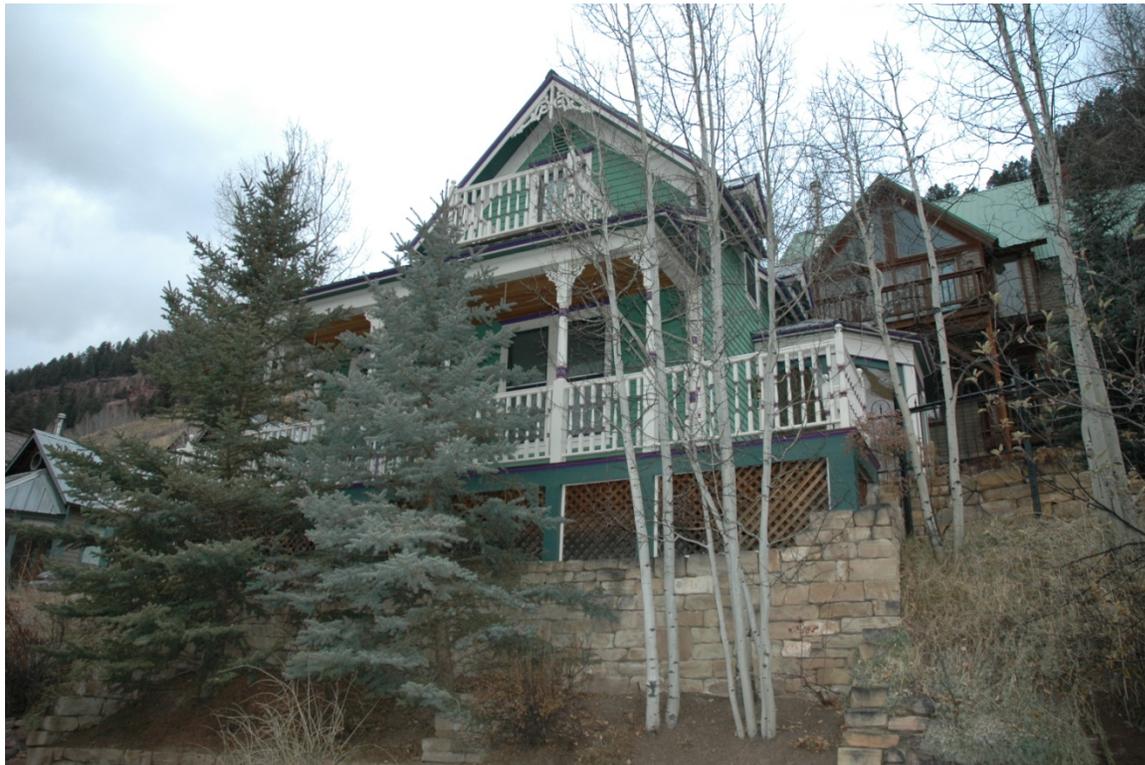
21. General architectural description:  
**This modern-appearing, tall 1½-story, wood frame residence, which overall measures approximately 33' N-S by 35' E-W. The dwelling is supported by a poured concrete foundation, while its exterior walls are clad with painted green horizontal wood siding with painted white 1" by 4" corner boards. The roof is a steeply-pitched cross gable with a shed-roofed extension to the north (rear) elevation. The roof is covered with metal roofing material and the boxed eaves are painted white. Gable ornaments appear in the upper gable ends on the west and south elevations. A prominent five-sided bay window is centered on the east elevation. The home's asymmetrical facade faces Gregory Avenue on the south elevation. The wood-paneled front door is painted green, with white and purple trim, and with a leaded glass light and a transom light. This door enters the west end of the facade from a full-width front porch which wraps around to cover the south end of the west elevation. The porch features a wood plank floor, a painted white open wood railing with turned balusters, painted white and purple turned columns with decorative brackets, and a low-pitched hipped roof. The porch roof also serves as an upper half story porch where a painted green glass-in-wood-frame door enters the house's upper level. A painted green wood-paneled door, with purple and white trim, enters the north elevation from a shed-roofed porch. A flagstone patio or terrace extends east of the house.**
