COLORADO CULTURAL RESOURCE SURVEY

Architectural Inventory Form

- 1. Resource number: **5SM.1749/THAS.88**
- 2. Temporary resource number: **N/A**
- 3. County: **San Miguel**
- 4. City: **Telluride**
- 5. Historic Building Name: **Miners' Hospital; Dr. Hall's Hospital; Hadley Hospital; American Legion Hospital; Community Hospital; San Miguel County Historical Museum**
- 6. Current Building Name: **Telluride Historical Museum**
- 7. Building Address: **201 W. Gregory Avenue**
- 8. Owner Name and Address: **Town of Telluride  
P. O. Box 397  
Telluride, CO 814350397**

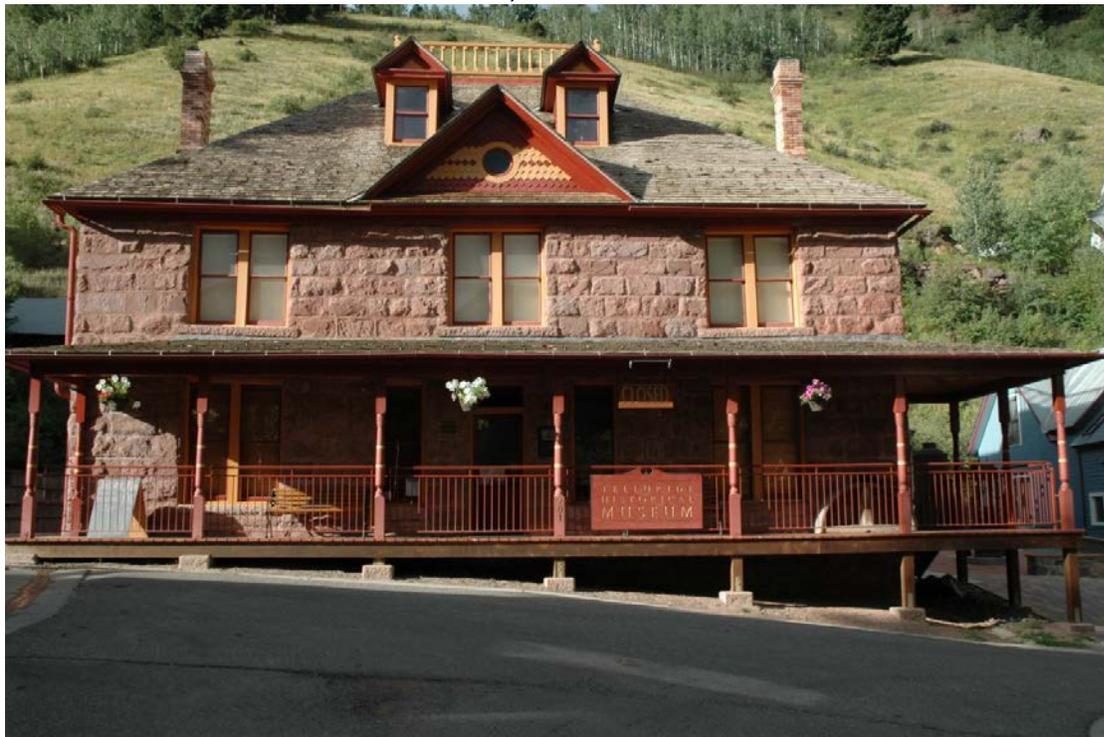
The Telluride Historical Museum building is a prominent 2½ edifice of sandstone masonry construction. It features a rectangular plan which measures 50' N-S (deep) by 46' E-W (across), and is covered by a steeply-pitched truncated hipped roof. The building is supported by a heavy sandstone foundation, with coursed sandstone forming the façade wall (south elevation) and uncoursed sandstone forming the side and rear elevation walls. The hipped roof is covered with wood shingles while the eaves are boxed with painted red wood trim. An open wood railing of turned balusters encloses the truncated roof peak. An intersecting gable, with decorative painted red and peach color variegated wood shingles and an oculus window, is centered on the south-facing roof slope overlooking the façade. Two gabled dormers, each with a 1/1 double-hung sash window, are also located on the south-facing roof slope. There are four tall brick chimneys with corbelled caps, two located respectively on the east and west facing roof slopes, and the other two near the base of the north-facing roof slope. The façade is symmetrical. A painted red wood-paneled door, with one upper sash light and a transom light, enters the center of the façade from a full-width 6' by 46' front porch which wraps around to cover the south end of the east elevation. The porch features a wood plank floor, a red metal railing, and painted red with peach trim turned columns which support a low-pitched hipped porch roof. A short set of metal steps approach the porch's east end. A concrete handicap-accessible ramp provides access to the porch's west end. A painted red wood-paneled door with a transom light enters the south end of the west elevation. Two other painted red wood-paneled doors with transom lights enter the main level on the north elevation. A metal staircase on the north elevation leads to a metal second story porch and yet another painted red wood-paneled door which enters the second story. Windows are entirely single and paired 1/1 double-hung sash with painted red wood frames and painted peach color wood surrounds.
