COLORADO CULTURAL RESOURCE SURVEY

Architectural Inventory Form

- 1. Resource number: **5SM.1679/THAS78**
- 2. Temporary resource number: **N/A**
- 3. County: **San Miguel**
- 4. City: **Telluride**
- 5. Historic Building Name: **Unknown**
- 6. Current Building Name: **Palamar House**
- 7. Building Address: **123 N. Oak Street**
- 8. Owner Name and Address: **Bill Pugh  
1517 Kirby Dr  
Houston, TX 77019**

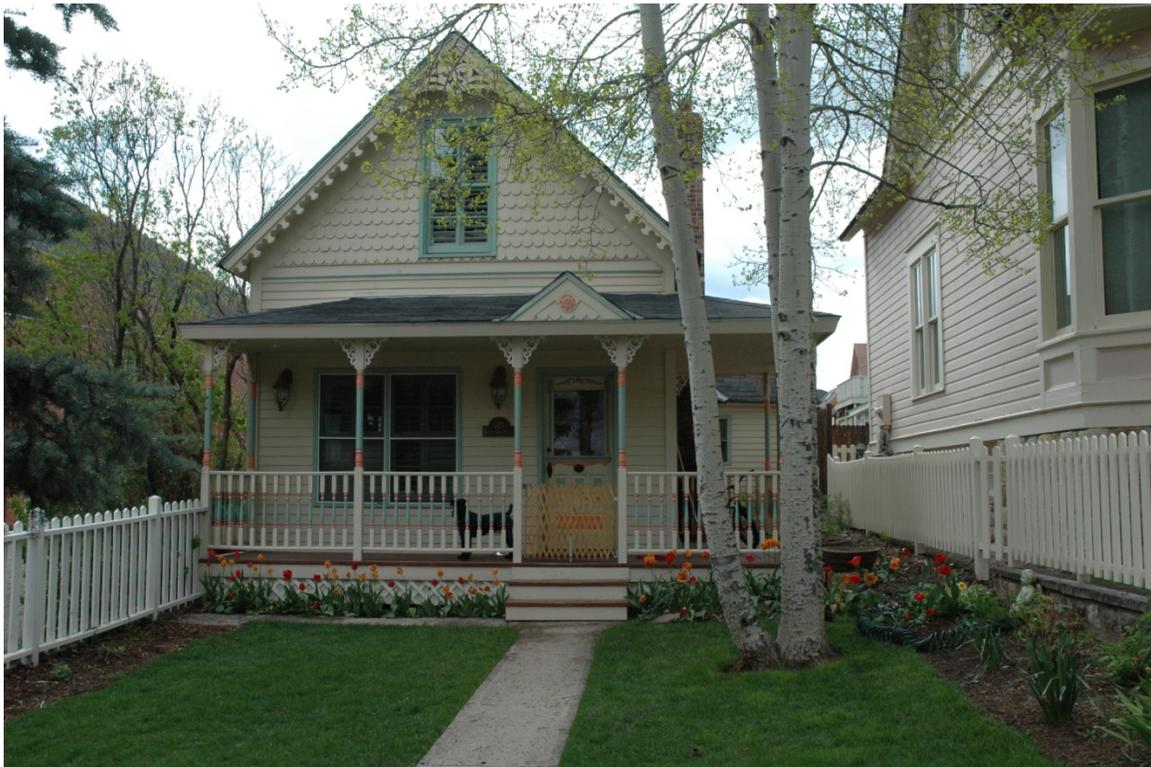
**Chimney**  
**Fence**
21. General architectural description:  
**This 1.5-story wood frame house rests on a low unpainted sandstone foundation, and its exterior walls are clad with painted cream yellow horizontal wood siding with 1" by 4" corner boards. Painted cream yellow fishscale shingles appear in the upper gable ends on the east and west elevations. The house is covered by a steeply-pitched front gable roof, with black asphalt composition shingles, and with painted cream yellow boxed eaves. Gable ornaments and decorative vergeboards appear in the upper gable ends. A non-historic red brick fireplace chimney is located on the north elevation. The dwelling's asymmetrical façade faces toward Oak Street on the east elevation. A painted cream yellow wood-paneled door, with painted mint green and salmon color trim, and with one upper sash light, enters the façade from the front porch. The porch itself is approached by two wooden steps, and features a wood floor, an open wood railing with turned balusters, turned columns with ornate brackets, and a low-pitched hip roof with a small intersecting gable over the entry stairs. The porch extends across the entire façade and wraps around to cover the east end of the north elevation. The home's windows consist of single and paired 4/4 double-hung sash windows, 4-light windows, and paired single-light windows, primarily with painted mint green wood frames and surrounds.**
