COLORADO CULTURAL RESOURCE SURVEY

Architectural Inventory Form

- 1. Resource number: **5SM.1640/THAS.171**
- 2. Temporary resource number: **N/A**
- 3. County: **San Miguel**
- 4. City: **Telluride**
- 5. Historic Building Name: **Unknown**
- 6. Current Building Name: **Bluepoint Grill**
- 7. Building Address: **123 S. Oak Street**
- 8. Owner Name and Address: **Edward L. Barlow
375 Park Ave. Suite 3800
New York, NY 10152**

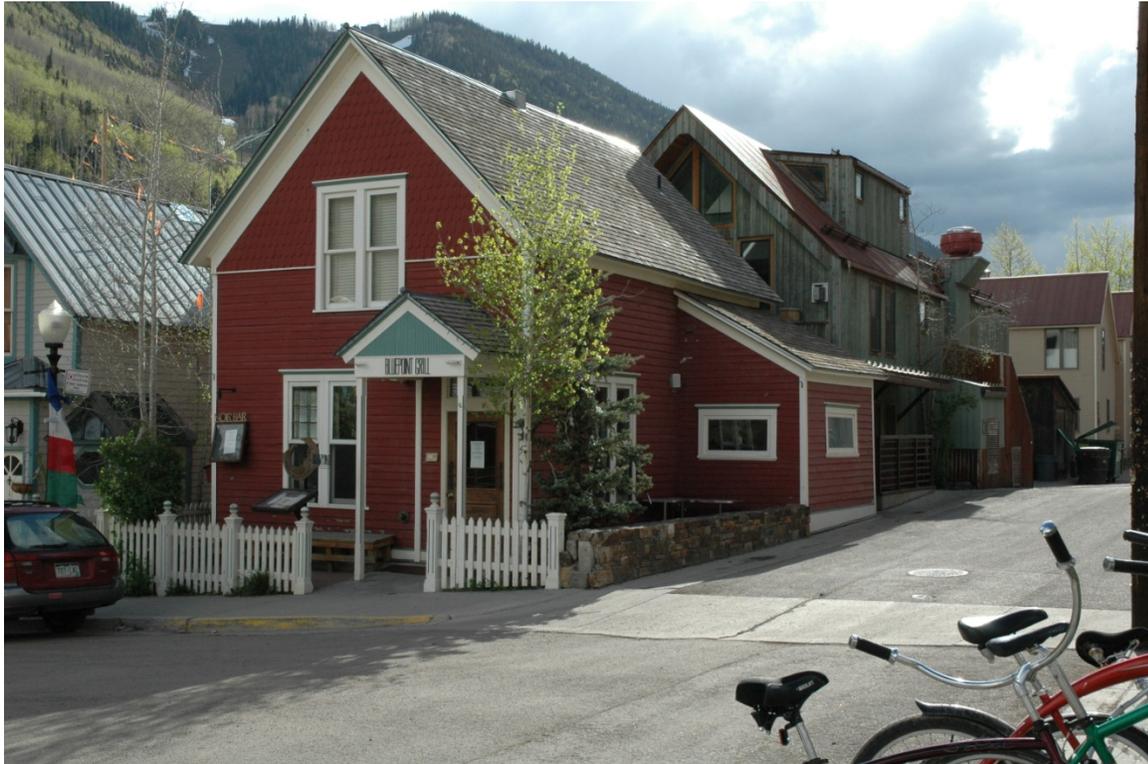
21. General architectural description:
This building consists of a 1.5-story wood frame, front-gable, dwelling, with a large rear addition joined to the original building by a connecting element. It appears that a new basement has been excavated beneath the historic building. The original dwelling is supported by a low concrete foundation, and its exterior walls are clad with painted red horizontal wood siding with painted cream white 1" by 4" corner boards. The front gable roof is steeply-pitched and is covered with wood shingles. The eaves are boxed with painted cream white and green wood trim. A metal clad chimney, which has been capped, is located near the center of the roof ridge. Two non-historic skylights penetrate the south-facing roof slope. Painted red fishscale shingles appear in the façade's upper gable end. The building's asymmetrical façade faces toward Oak Street on the east elevation. Here, a stained brown wood-paneled door, with one upper sash light and with a transom light, enters the north end of the façade from a small porch. This porch features a concrete floor, and a gable roof supported by two painted cream white chamfered 4" by 4" wood posts, and two engaged 4" by 4" wood posts. Two sets of paired 1/1 double-hung sash windows, with painted cream white wood frames and surrounds, penetrate the façade wall - one set to the south of the porch, and the other in the upper gable end. The north elevation is also penetrated by a set of paired 1/1 double-hung sash windows with painted cream white wood frames and surrounds. An older 6' by 12' shed-roofed extension on the north elevation is penetrated by a single-light fixed-pane window. The south elevation is penetrated by two 15-light fixed-pane windows with painted cream white wood frames and surrounds. A set of metal stairs on the south elevation descends to a basement-level door. The large, modern, addition rests on a concrete foundation, and has painted green vertical wood exterior siding. It is covered by a steeply-pitched gable roof, with a shed-roofed dormer on the north-facing roof slope.

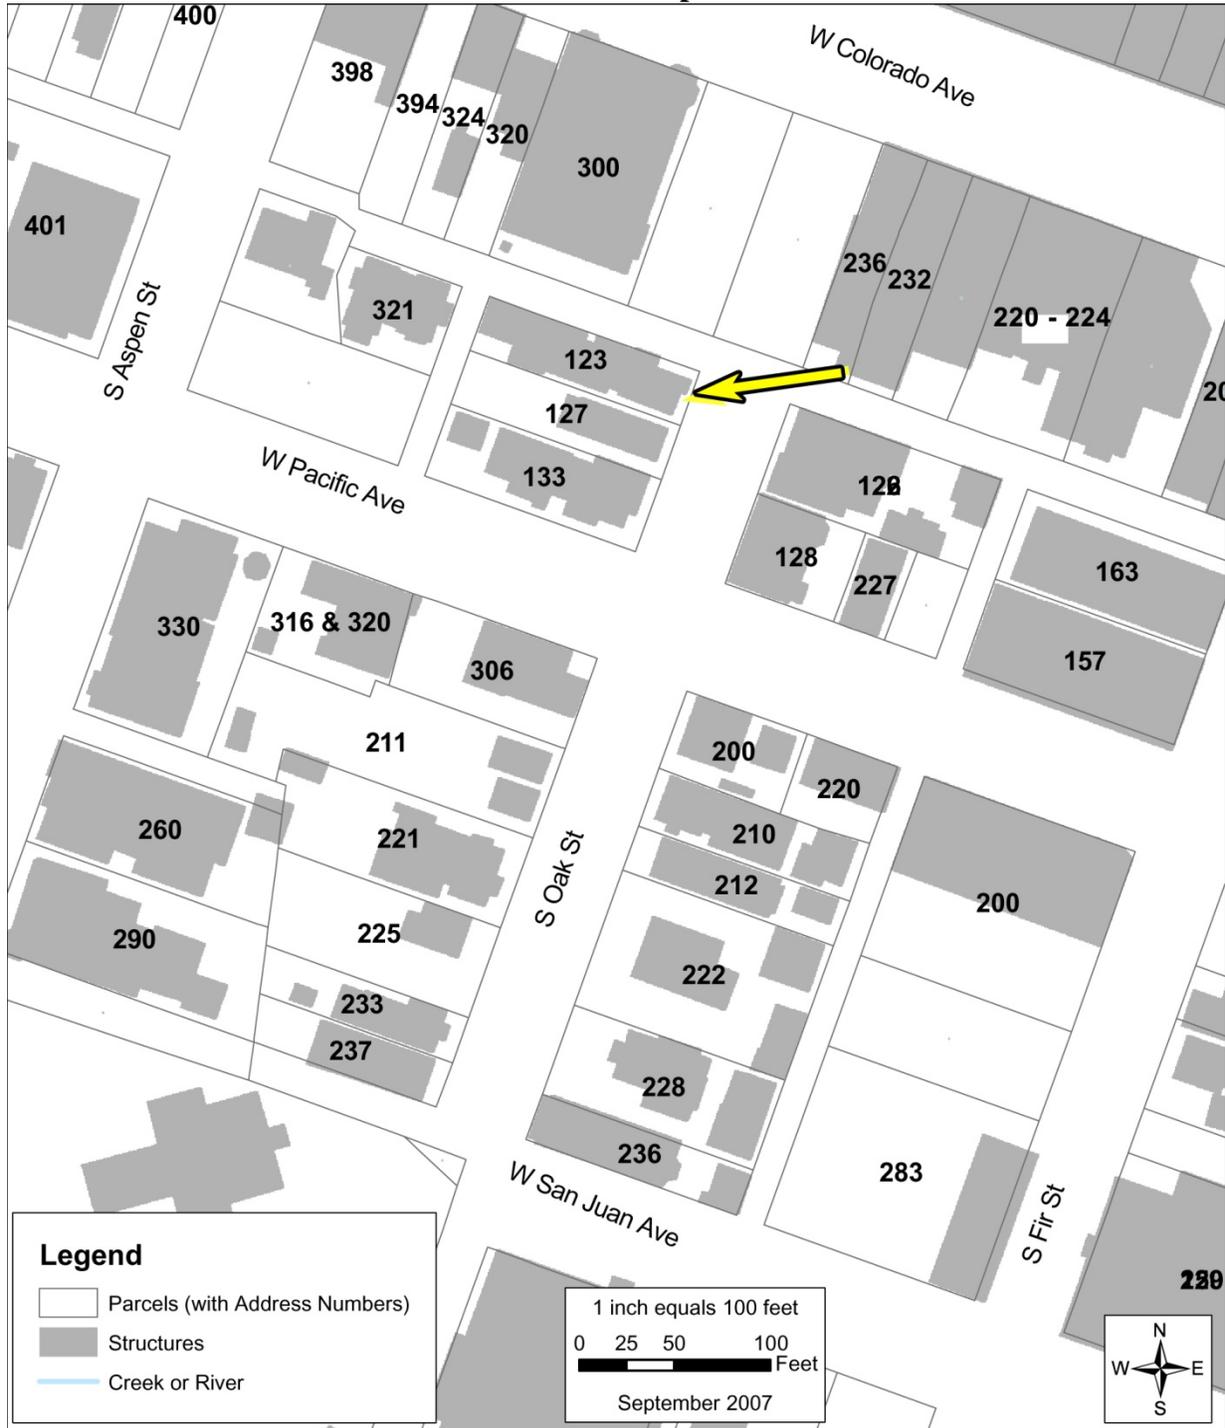
Sketch Map

This property is located on the west side of South Oak Street in the block between Colorado and Pacific Avenues. It is the first building south of the alley.
