COLORADO CULTURAL RESOURCE SURVEY

Architectural Inventory Form

- Determined Eligible – National Register
- Determined Not Eligible – National Register
- Determined Eligible – State Register
- Determine Not Eligible – State Register
- Need Data
- Contributes to eligible National Register District
- Noncontributing to eligible National Register District

- 1. Resource number: **5SM.1638**
- 2. Temporary resource number: **N/A**
- 3. County: **San Miguel**
- 4. City: **Telluride**
- 5. Historic Building Name: **Davis Houses**
- 6. Current Building Name: **Twin Bricks Professional Building**
- 7. Building Address: **128 S. Oak Street**
- 8. Owner Name and Address: **Bernice C. Garber  
P. O. Box 674  
Telluride, CO 814350674**

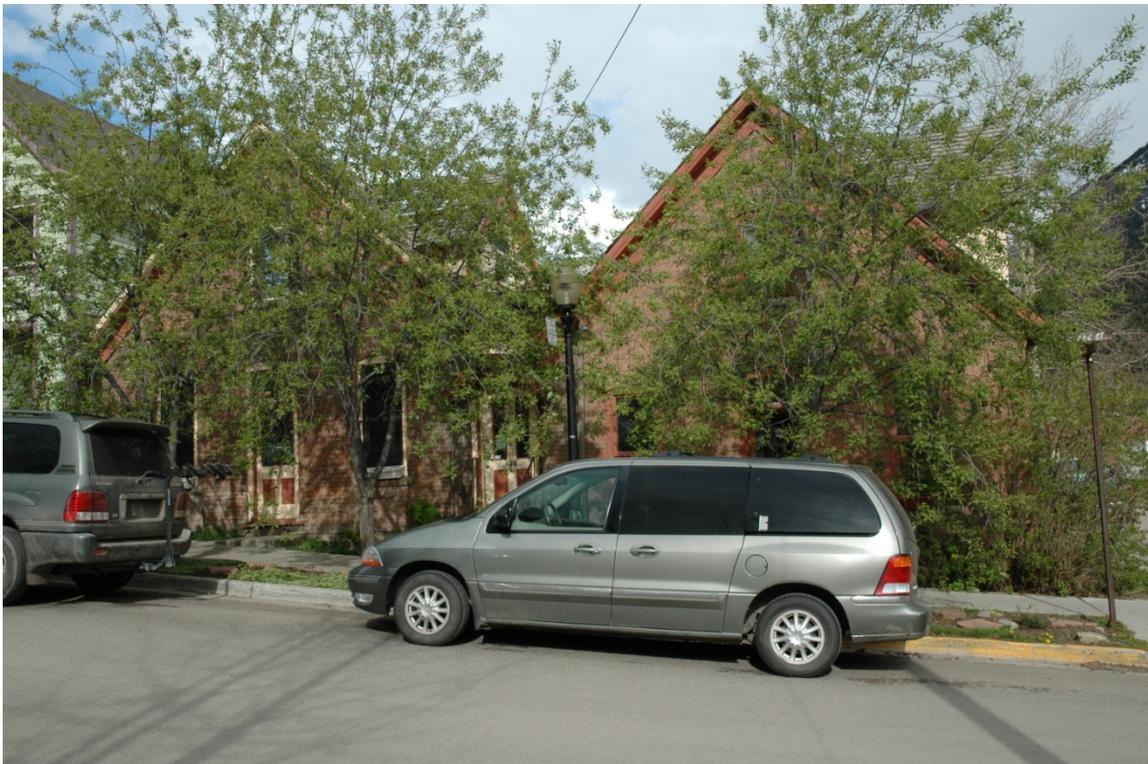
**Roof Treatment/Dormer**
21. General architectural description:  
**The Twin Bricks Professional Building at the northeast corner of Oak Street and Pacific Avenue is made up of two 1899 brick dwellings, joined by a center addition, and with two large bay additions to the east (rear) elevation. Each of the twin dwellings originally measured 22' N-S by 33' E-W, and were separated by a space of just four feet - this space has been filled in by the addition which joins the two originally separate dwellings. The entire building now measures 48' N-S (across) by 33' E-W (deep), not including the two bays on the east elevation.**

- The building is supported by a low, unpainted, sandstone foundation, and its walls are made of red brick laid in running bond. The façade fronts directly onto the sidewalk paralleling Oak Street on the west elevation. Here, three wood-paneled entry doors, with transom lights and segmental brick arches, enter the building. Two of these doors respectively enter the historically separate dwellings, while the third door enters the center addition. Both of the original doors are flanked on either side by 1/1 double-hung sash windows with painted cream white wood surrounds, concrete or sandstone lugsills, and segmental brick arches. The façade upper gable ends of the two historically separate building's are respectively penetrated by a single-light fixed-pane window, and by a 1/1 double-hung sash window. Double-hung sash windows also penetrate the upper gable ends on the east (rear) elevation. The south elevation, which faces Pacific Avenue, is penetrated by two 1/1 double-hung sash windows, with painted red wood surrounds, sandstone or concrete lugsills, and segmental brick arches. A stained natural brown wood-paneled door, with nine upper sash lights, enters the east end of the south elevation from a small 2-**

**step concrete porch. This porch is covered by a gable hood with knee brace supports. A rear entry door is incorporated into one of the two hip-roofed bay additions to the east elevation. The east elevation is also penetrated by four 1/1 double-hung sash windows with segmental brick arches. Non-historic gabled dormers are located on the north and south-facing roof slopes.**
