COLORADO CULTURAL RESOURCE SURVEY

Architectural Inventory Form

- 1. Resource number: **5SM.1637**
- 2. Temporary resource number: **N/A**
- 3. County: **San Miguel**
- 4. City: **Telluride**
- 5. Historic Building Name: **Unknown**
- 6. Current Building Name: **205 South Oak Residences Building**
- 7. Building Address: **205 S. Oak Street / 306 W. Pacific Avenue**
- 8. Owner Name and Address: **Brownstone Partners LLC
P. O. Box 2520
Telluride, CO 814352520**

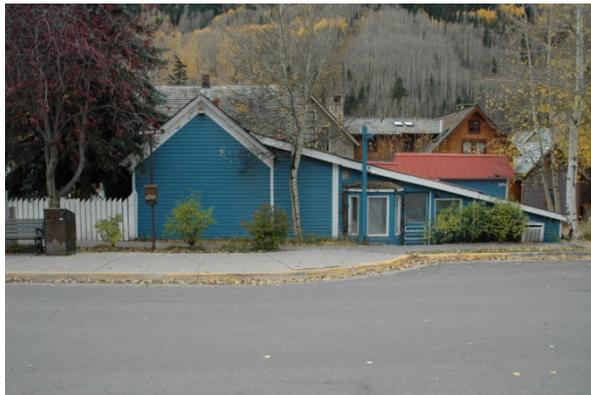
205 S. Oak Street before construction of addition and renovation work. Photo August 2007.

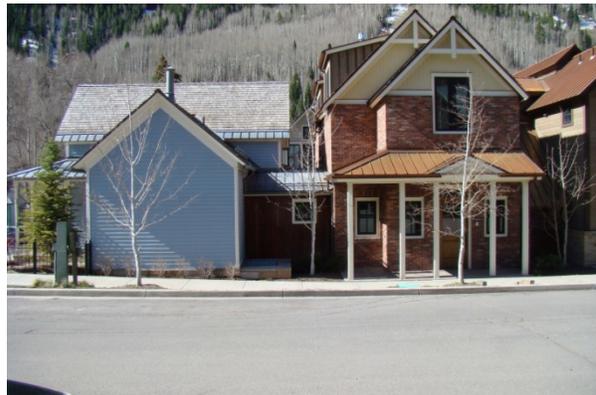
205 S. Oak Street after construction of addition and renovation work. Photo March 2012

Note: The dwelling at 205 S. Oak Street was intensively surveyed in August 2007 during phase one of the Telluride Re-Survey of Historic Structures project. Subsequent to that time, the dwelling was substantially renovated and a large addition was built onto the west elevation, joined to the original by a connecting element. This form’s architectural description (fields 14-21 below) relate to the dwelling’s appearance as it existed in August 2007. The form’s eligibility evaluation (fields 37-46 below) relates to the dwelling as it exists in April 2012, following the renovation.
