COLORADO CULTURAL RESOURCE SURVEY

Architectural Inventory Form

- 1. Resource number: **5SM.1627**
- 2. Temporary resource number: **N/A**
- 3. County: **San Miguel**
- 4. City: **Telluride**
- 5. Historic Building Name: **Unknown**
- 6. Current Building Name: **Telluride Real Estate Solutions Building**
- 7. Building Address: **210 S. Oak Street**
- 8. Owner Name and Address: **Telluride Real Estate Solutions II
120 S. Pine Street
Telluride, CO 81435**

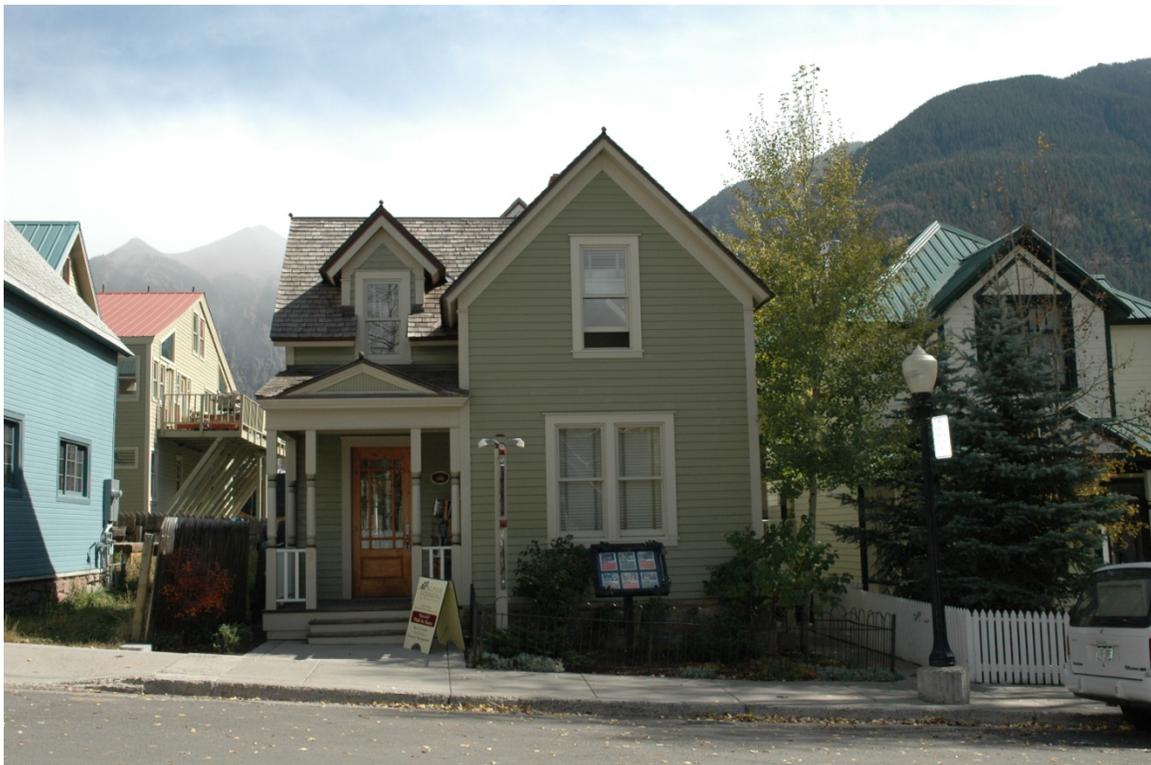
21. General architectural description:
The present building at 210 S. Oak Street consists of a historic 1.5-story dwelling, and large modern, two-story rear addition which has significantly more than doubled the size of the original house. No longer used as a residence, the building presently is home to Alpine Lodging and Real Estate and Montana Placer Inn. The original house is supported by a low sandstone foundation, and its exterior walls are clad with painted green horizontal wood siding with painted cream white 1" by 6" corner boards. The original house is covered by a steeply-pitched cross gable roof, with wood shingles and boxed eaves. A red brick chimney is located on the ridge, while a non-historic skylight is located on the south-facing roof slope. A stained natural brown glass-in-wood-frame front door enters the façade (west elevation) from a 3-step wood porch. This non-historic porch features a wood plank floor, an open painted white wood railing, turned columns and a gable and shed roof. The façade wall is penetrated by a set of paired 1/1 double-hung sash windows, and by a single 1/1 double-hung sash window in the upper gable end. There is also a gabled wall dormer with a 1/1 double-hung sash window. The large, two-story rear addition is presently utilized as lodging by the Montana Placer Inn. The addition's exterior walls are made of painted beige vertical wood siding, with painted white 1" by 6" corner boards. The addition's gable roof is covered with metal roofing material, and the eaves are boxed with painted white wood trim. Two large shed-roofed dormers are located on the north-facing roof slope. Multiple entry doors enter the addition's north elevation from a full-length shed-roofed porch.
