COLORADO CULTURAL RESOURCE SURVEY

Architectural Inventory Form

- 1. Resource number: **5SM.1636**
- 2. Temporary resource number: **N/A**
- 3. County: **San Miguel**
- 4. City: **Telluride**
- 5. Historic Building Name: **Unknown**
- 6. Current Building Name: **211 South Oak Residences**
- 7. Building Address: **211 S. Oak Street**

| 48. Report title: | <b>Town of Telluride Re-Survey of Historic Structures</b> | | <b>Planning and Building<br/>Department</b> |

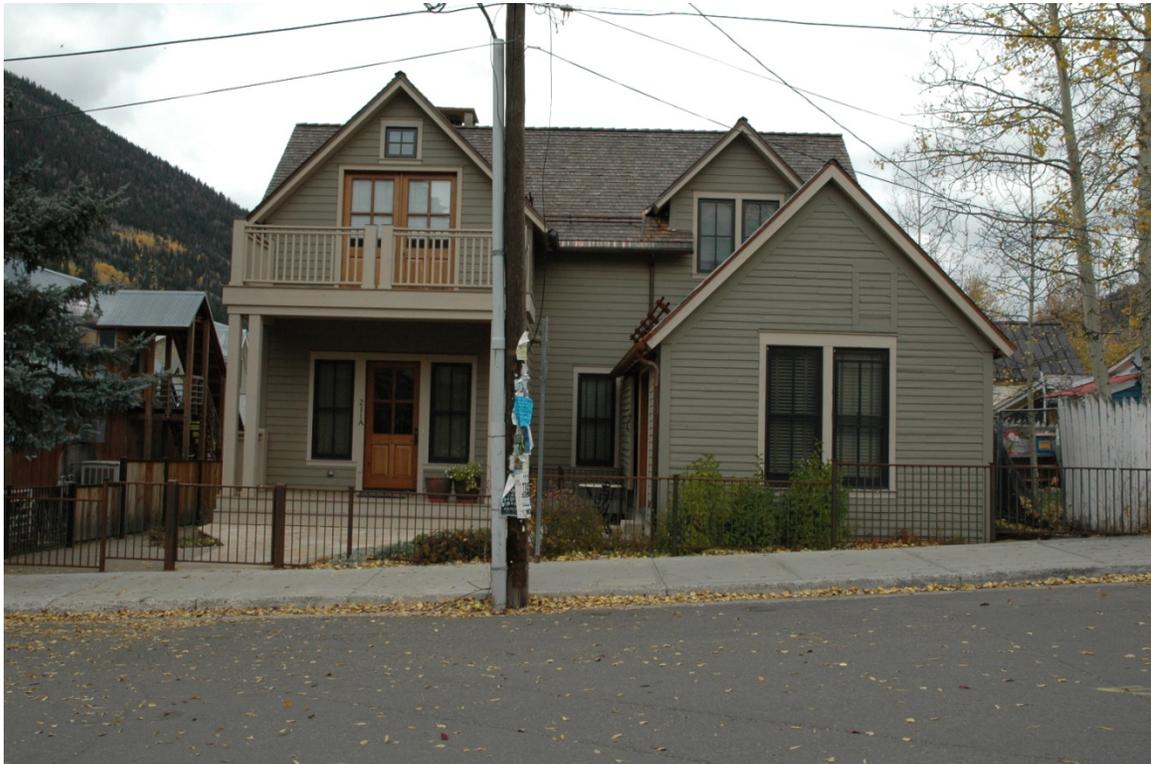
**Chimney**  
**Balcony**  
**Fence**
21. General architectural description:  
**The "211 South Oak Residences" building is a large multi-unit residential building. It is supported by a concrete foundation, and its exterior walls are clad either with horizontal wood siding or with vertical wood siding. The building features multiple gable roofs. A primary entry door leads into the south end of the east elevation (façade) from a concrete porch. The roof over this porch also serves as a balcony for the upper half story. Windows are predominantly 2/2 double-hung sash. Two large fireplace chimneys are generally located along the south (side) elevation. Additional entry doors are located on the north and south elevations.**
