COLORADO CULTURAL RESOURCE SURVEY

Architectural Inventory Form

I. IDENTIFICATION

47. Photograph number(s):	<b>CD #7, Images 136-142</b>	CDs filed at:	<b>Town of Telluride</b>
48. Report title:	<b>Town of Telluride Re-Survey of Historic Structures</b>		<b>Planning and Building Department</b>
49. Date(s):	<b>09/30/2009; revised 4/10/2012</b>		<b>113 West Columbia Avenue</b>
50. Recorder(s):	<b>Carl McWilliams Timothy Wilder</b>		<b>Telluride, CO 81435</b>
51. Organization:	<b>Cultural Resource Historians</b>		
52. Address:	<b>Dogwood Court Fort Collins, CO 80525</b>		
53. Phone number(s):	<b>(970) 493-5270</b>

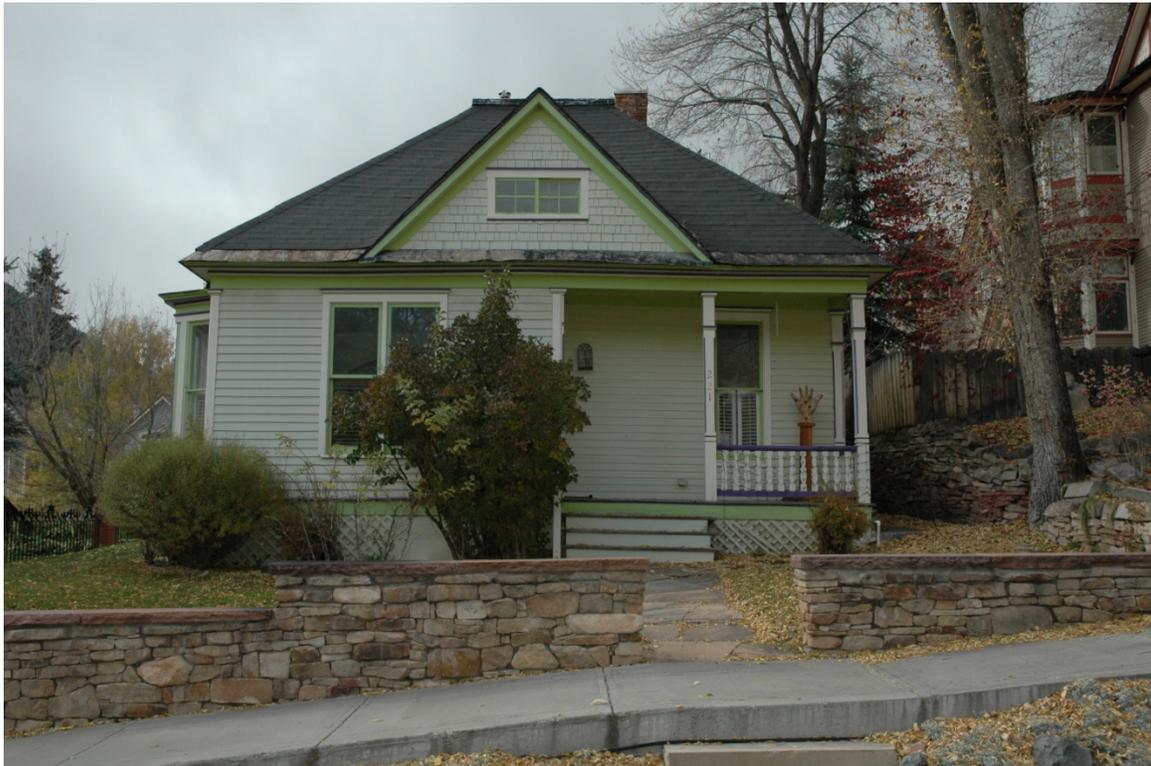
21. General architectural description:  
**This is a 1.5-story wood frame hipped-roof box type dwelling. It is supported by a low sandstone foundation, and its exterior walls are clad with painted pale green horizontal weatherboard siding with 1" by 6" corner boards. A painted olive green 1" by 8" board, with a painted purple wood water table, separates the foundation from the horizontal wood siding. The house is covered by a steeply-pitched truncated hip roof, with black asphalt shingles, and with painted olive green and purple boxed eaves. An intersecting gable overlooks the façade (east elevation), and features square-cut wood shingle and a set of paired 4-light windows. A red brick chimney is located just below the ridge on the north-facing roof slope. A painted cream white, with olive green trim, glass-in-wood-frame door, with a transom light, enters the house from a cut-away porch which is recessed under the north half of the façade. The porch is approached by three wooden steps, and features a tongue-in-groove wood floor, an open wood balustrade, and chamfered square post supports with capitals. A painted white wood-paneled door enters an enclosed shed-roofed mud porch at the north end of the west (rear) elevation. A canted hip-roofed bay, with four 1/1 double-hung sash windows and decorative recessed panels, is located on the south elevation. Windows elsewhere are primarily single and paired 1/1 double-hung sash, with painted olive green and purple wood frames and surrounds.**
