COLORADO CULTURAL RESOURCE SURVEY

Architectural Inventory Form

I. IDENTIFICATION

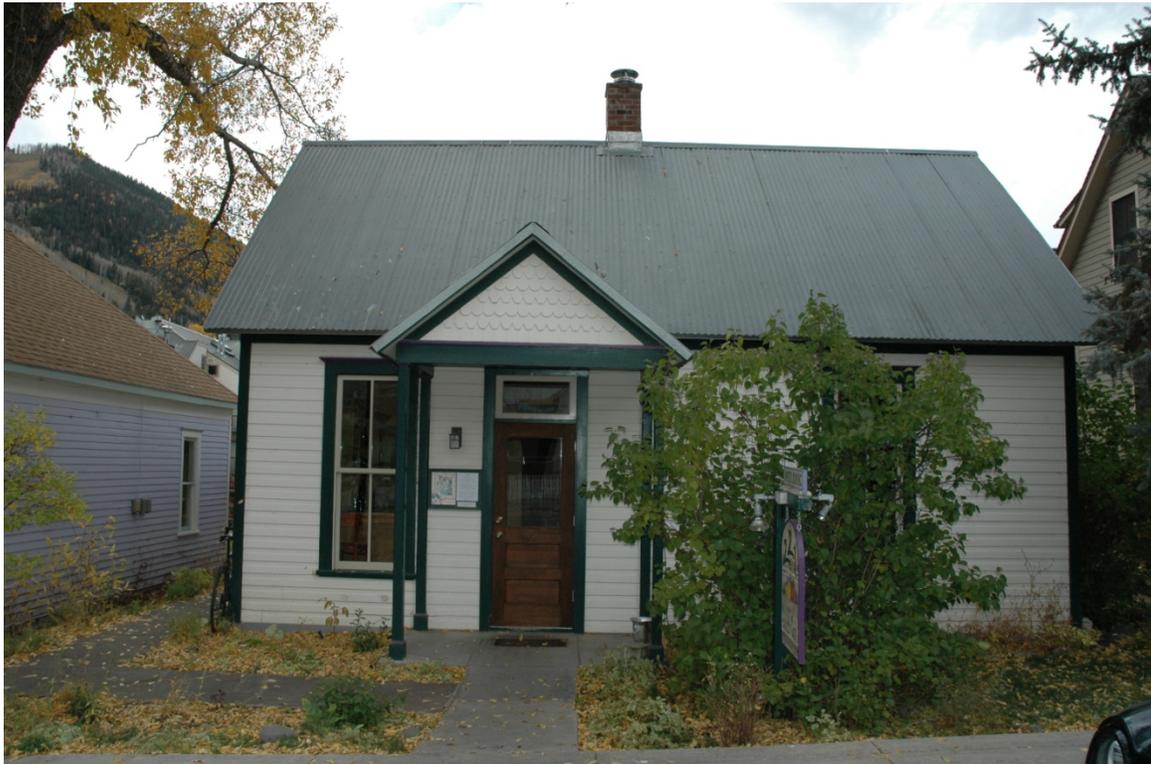
**This building consists of an original single story, side gabled dwelling, with a large 1.5-story gabled rear addition. The historic side gabled dwelling portion of the building measures just 28' N-S (across) by 18' E-W (deep), while the addition measures approximately 33' N-S by 40' E-W. The entire building is supported by a non-historic concrete foundation, and it appears a modern basement has been excavated beneath the historic dwelling. The original house's exterior walls are clad with painted cream white horizontal weatherboard siding, with painted green 1" by 4" corner boards, and the side gable roof is steeply pitched, and is covered with corrugated metal roofing material. The eaves are boxed with painted green wood trim, and a red brick chimney is located on the ridge. The façade of the original house faces toward Oak Street on the east elevation. A stained brown wood-paneled front door, with one upper sash light and with a transom light, enters the façade from a small concrete porch covered by a gable roof. The porch roof is supported by two painted green chamfered 4" by 4" wood posts, and by two painted green engaged wood posts. Variegated wood shingles appear in the porch roof's upper gable end. The porch is flanked on either side by a 2/2 double-hung sash window with painted cream white wood frames, painted green wood surrounds, and painted purple wood cornices. The north and south (side) elevations are also penetrated by 2/2 double-hung sash windows with painted cream white wood frames, painted green wood surrounds, and painted purple wood cornices. A wooden staircase, covered by a shed-roofed awning, descends to a basement-level door on the north elevation. The large rear (west elevation) addition features stained brown vertical wood plank walls, and a steeply pitched gable roof with metal roofing material. The entire building is now utilized by the "221 South Oak Street A Bistro" restaurant.**
