COLORADO CULTURAL RESOURCE SURVEY

Architectural Inventory Form

- 1. Resource number: **5SM.1684**
- 2. Temporary resource number: **N/A**
- 3. County: **San Miguel**
- 4. City: **Telluride**
- 5. Historic Building Name: **Unknown**
- 6. Current Building Name: **231 Oak Street LLC House**
- 7. Building Address: **231 N. Oak Street**
- 8. Owner Name and Address: **1350 Connecticut Avenue NW, Suite 800
Washington, DC 20036**

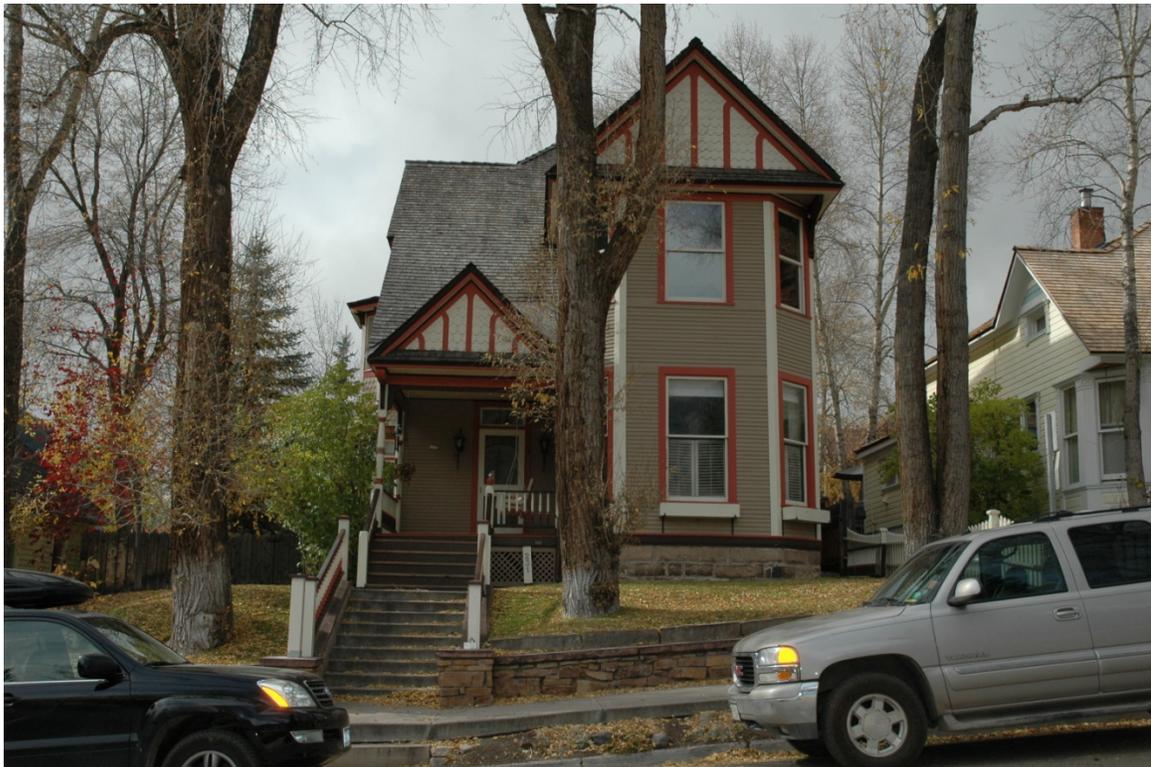
21. General architectural description:
This a 2.5-story 1890s wood frame dwelling, with a large 1.5-story addition to its west (rear) elevation. The original house is supported by a low sandstone foundation, and its exterior walls are clad with painted beige horizontal wood siding with painted cream white 1" by 4" corner boards. A painted dark brown beveled 1" by 8" board with a painted salmon color wood water table separates the foundation from the horizontal siding. Painted cream white patterned wood shingles, and false half-timbering, appear in the upper gable ends on the façade (east elevation) and on the south (side) elevation. The house is covered by a steeply-pitched hip roof with prominent intersecting gables on the façade and south elevations. The roof is covered with wood shingles and the eaves are boxed with painted cream white and salmon color wood trim. A tall red brick chimney, with decorative brick work, is located near the base of the north-facing roof slope. The house features an asymmetrical façade which faces toward Oak Street on the east elevation. A stained brown wood-paneled door, covered by a painted cream white wood storm door, and with a transom light, enters the south half of the façade from a 6-step wood porch. This porch is recessed under the front southeast corner of the roof eave, and features a tongue-in-groove wood floor, an open wood railing with turned balusters, turned columns with brackets, and is topped by a small intersecting gable with false half timbering. A prominent two-story canted bay window, with three 1/1 double-hung sash first story windows and three 1/1 double-hung sash second story windows, dominates the façade to the north of the entry porch. A non-historic, two-story, five-sided, bay is located on the south elevation. This bay is covered by an intersecting hip roof, and features five single-light first story windows

with transom lights, and five single-light second story windows. Windows elsewhere are predominantly 1/1 double-hung sash with painted cream white wood frames and painted salmon color wood surrounds.

The addition to the west (rear) elevation is joined to the original dwelling by a connecting element. It is supported by a low concrete foundation, and its exterior walls are of painted grey or beige brick, with stone or simulated stone at the corners and in a belt course. The addition is covered by a steeply-pitched gable roof with a tower at the west end of the south elevation. The primary entry door into the addition is located beneath a gable hood on the south elevation. A tall, nearly full-length, vertically-oriented, multi-paned, window with a rounded top is located near the east end of the north elevation. Another rounded arch window is located in the upper gable end of an intersecting gable on the north elevation.

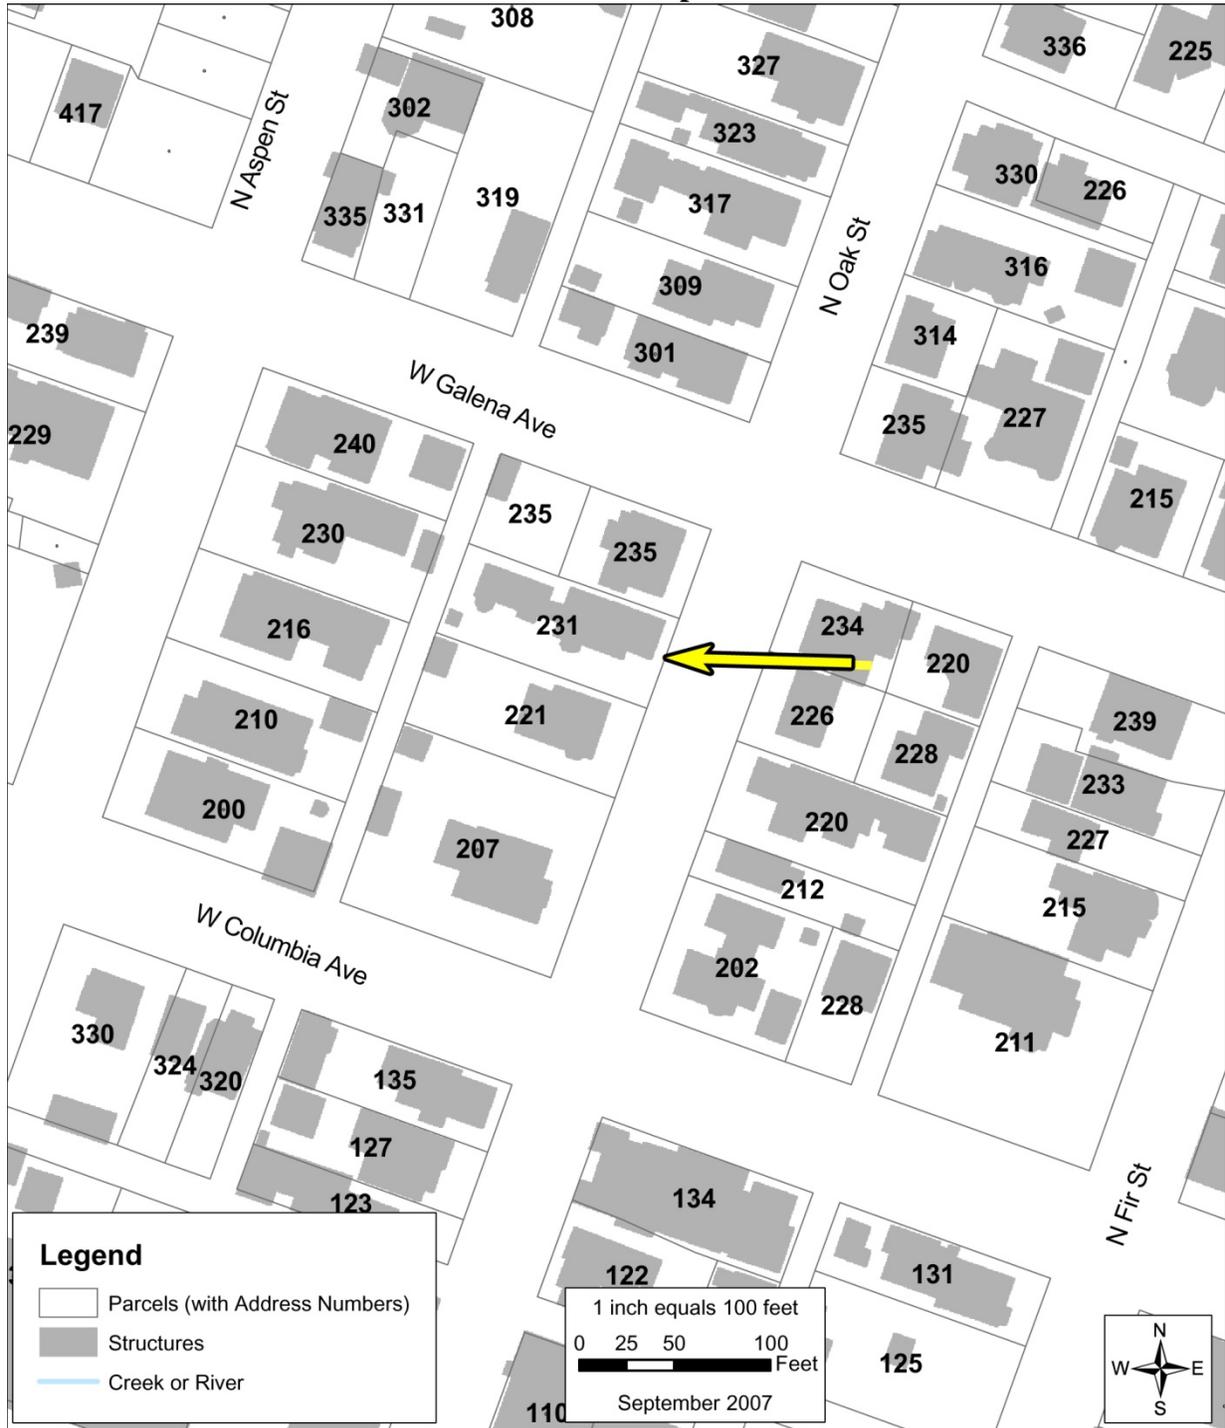
Sketch Map

23. Landscape or special setting features:
This property is located on the west side of N. Oak Street in the block between Columbia and Galena Avenues. The planted grass front yard is nicely landscaped and includes three large deciduous trees. A low sandstone retaining wall parallels the front sidewalk along Oak Street. Much of what historically was the backyard is now occupied by a large addition to the original house.
