COLORADO CULTURAL RESOURCE SURVEY

Architectural Inventory Form

- 1. Resource number: **5SM.1697**
- 2. Temporary resource number: **N/A**
- 3. County: **San Miguel**
- 4. City: **Telluride**
- 5. Historic Building Name: **Olson House**
- 6. Current Building Name: **234 N. Oak Street LLC House**
- 7. Building Address: **234 N. Oak Street**
- 8. Owner Name and Address: **234 N. Oak Street, LLC
40 Blackland Road NW
Atlanta, GA 30342**

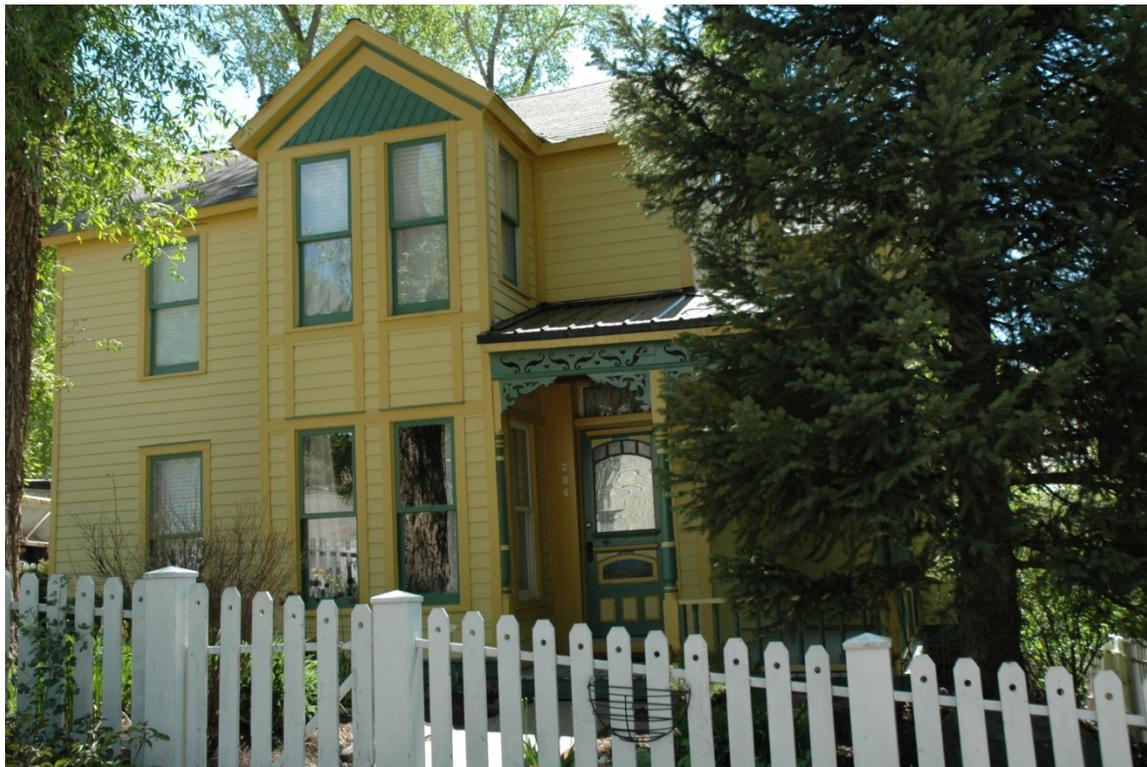
THLD RATING:	Contributing to District
---------------------	---------------------------------

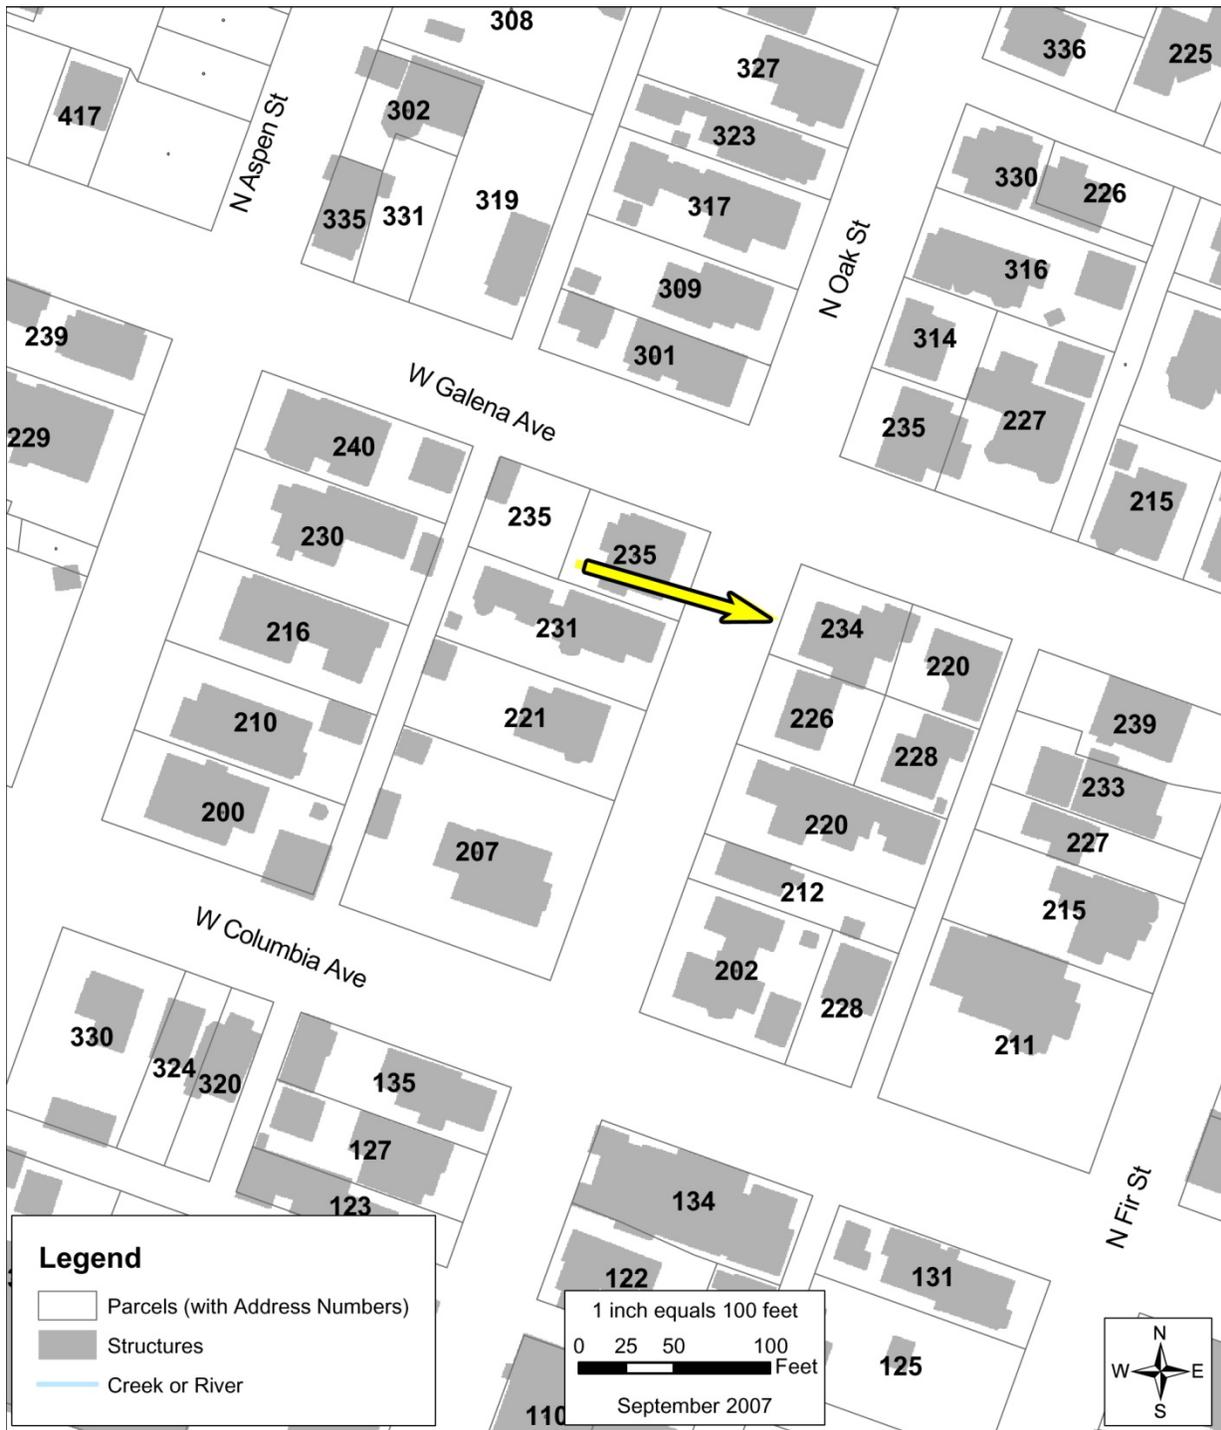
Sketch Map

This well-maintained property is located at the southeast corner of Oak Street and Galena Avenue, toward the north end of the Telluride National Historic Landmark District. A painted white picket fence encloses the front yard and side yards. The grounds are nicely landscaped with low native plants and flowers, including numerous columbines.
