COLORADO CULTURAL RESOURCE SURVEY

Architectural Inventory Form

- 1. Resource number: **5SM.1685/THAS68**
- 2. Temporary resource number: **N/A**
- 3. County: **San Miguel**
- 4. City: **Telluride**
- 5. Historic Building Name: **Unknown**
- 6. Current Building Name: **House**
- 7. Building Address: **235 N. Oak Street**
- 8. Owner Name and Address: **A and P Telluride LLC
P.O. Box 753
Telluride, CO 814350753**

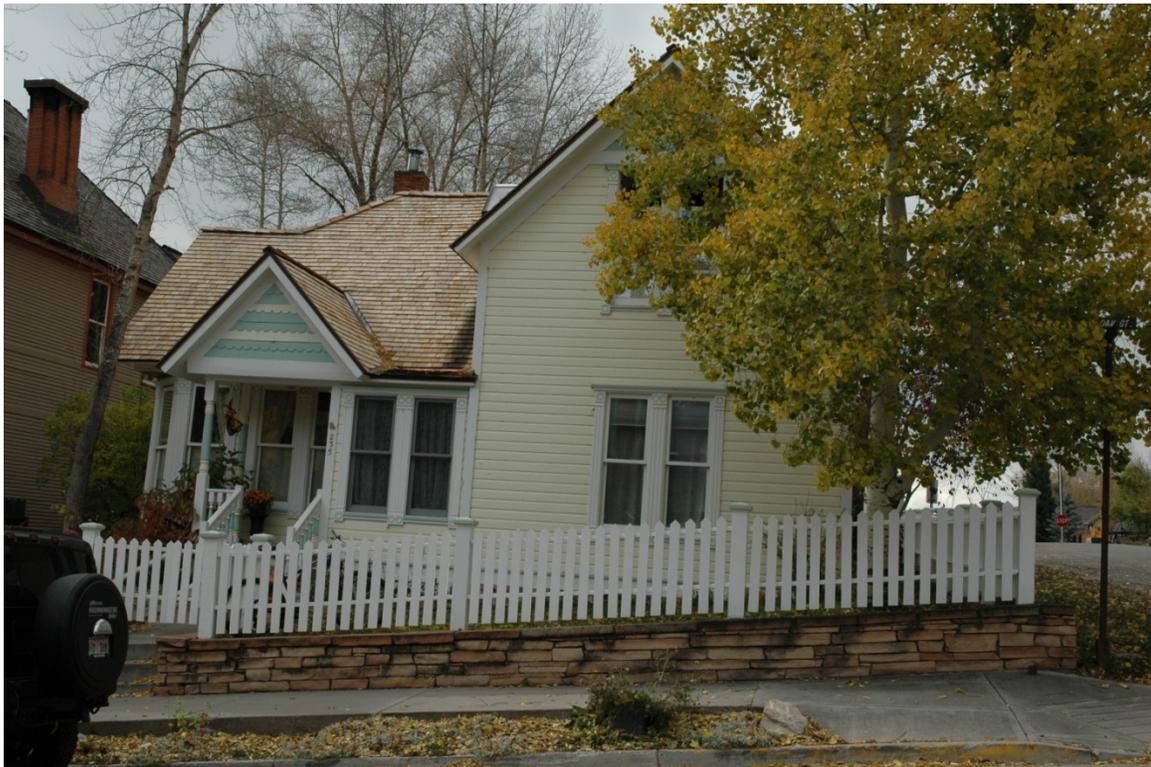
21. General architectural description:
This 1.5-story wood frame dwelling is supported by a low coursed sandstone foundation, and its exterior walls are clad with painted yellow horizontal weatherboard siding with painted white 1" by 4" corner boards. A painted white 1" by 8" board with a painted mint green wood water table separates the foundation from the horizontal siding. The house is covered by a steeply-pitched gable-on-hip roof, with brown wood shingles and painted white boxed eaves. A red brick chimney is located on the west-facing roof slope, while non-historic skylights are located on the east and south-facing roof slopes. Painted mint green and yellow variegated wood shingles appear in the upper gable ends. The house features an asymmetrical façade which faces toward Oak Street on the east elevation. A non-historic stained brown wood-paneled door, with one upper sash light, enters the south end of the façade from a 4-step wood porch. Approached by flagstone steps, the porch features a wood plank floor, an open wood railing with turned balusters, turned columns, and a gable roof. A stained brown wood-paneled door, with one upper sash light, enters the north end of the west (rear) elevation from a concrete patio covered by a gable roof. A three-sided bay, with three 1/1 double-hung sash windows, forms the front southeast corner of the house. Painted yellow wood panels appear beneath the bay's windows. A set of paired 1/1 double-hung sash windows penetrate the façade wall just to the north of the front porch. Sets of paired first and second story 1/1 double-hung sash windows penetrate the north end of the façade wall. Windows elsewhere are also primarily 1/1 double-hung sash with painted white wood frames and surrounds. Modest, somewhat older, shed-roofed additions are located on the south and west elevations.
