COLORADO CULTURAL RESOURCE SURVEY

Architectural Inventory Form

- 1. Resource number: **5SM.1855**
- 2. Temporary resource number: **N/A**
- 3. County: **San Miguel**
- 4. City: **Telluride**
- 5. Historic Building Name: **Merchandise Warehouse; Grocery Warehouse**
- 6. Current Building Name: **Paragon Ski & Sport Building**
- 7. Building Address: **236 S. Oak Street**
- 8. Owner Name and Address: **Telluride Crosscut, LLC
P. O. Box 2466
Telluride, CO 814352466**

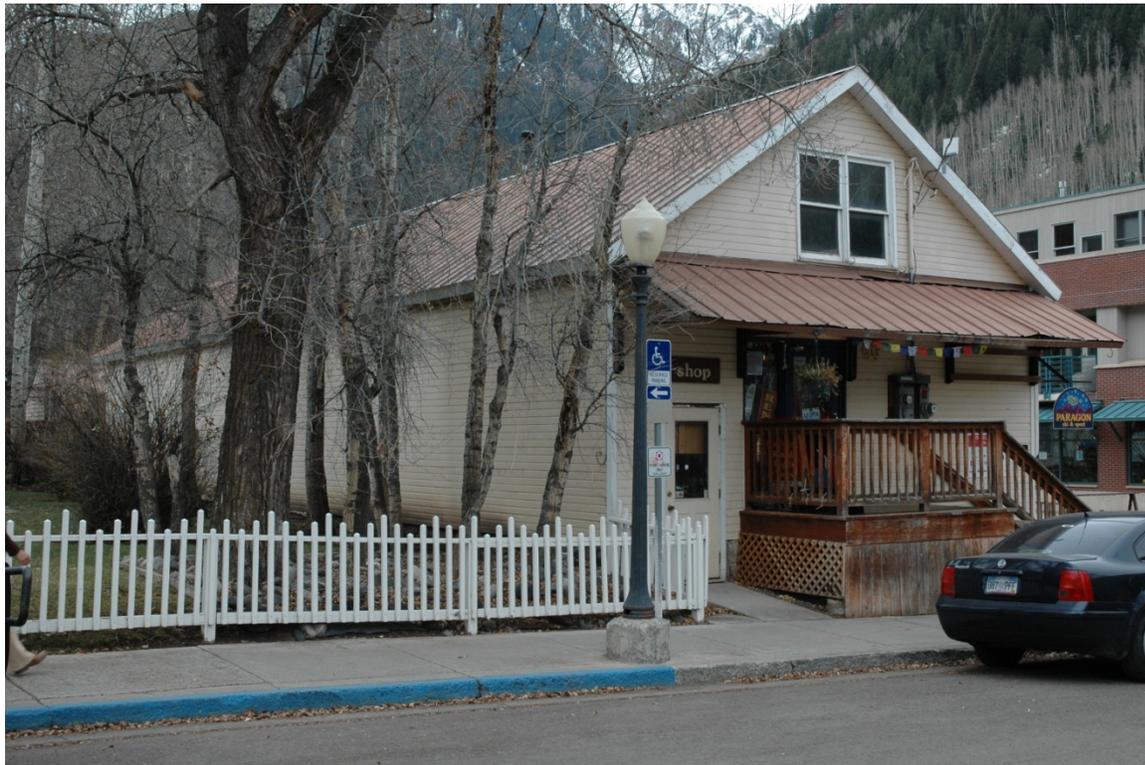
THLD RATING:	Primary - Noncontributing Without Qualifications Garage – Non-Designated – New Construction
---------------------	--
