COLORADO CULTURAL RESOURCE SURVEY

Architectural Inventory Form

- 1. Resource number: **5SM.1686**
- 2. Temporary resource number: **N/A**
- 3. County: **San Miguel**
- 4. City: **Telluride**
- 5. Historic Building Name: **Unknown**
- 6. Current Building Name: **Gluckstern House**
- 7. Building Address: **301 N. Oak Street**
- 8. Owner Name and Address: **Judith O. Connor Gluckstern, c/o Ajax Capi
P. O. Box 2280
Telluride, CO 81435**

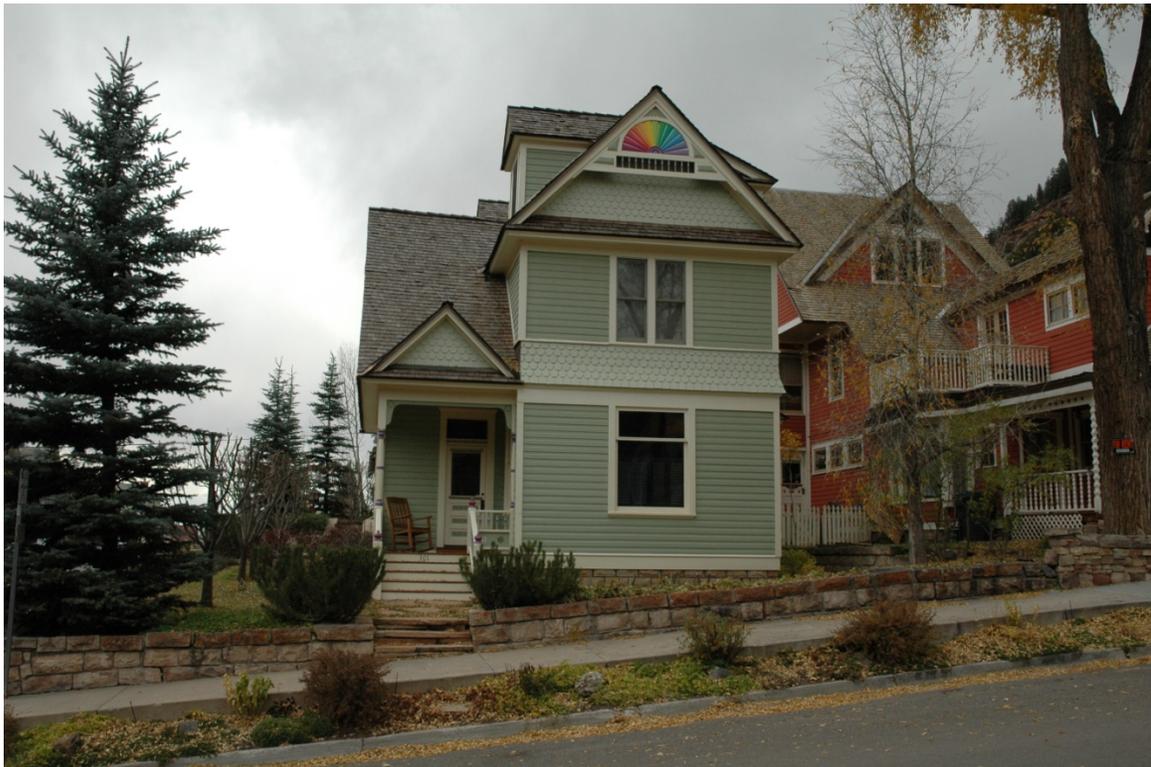
21. General architectural description:
This building consists of a historic, 1890s, 2.5-story cross-gabled dwelling, with a large, circa 1997 addition to its west (rear) elevation. The original dwelling measures 28' N-S (across) by 28' E-W (deep), including an 8' by 8' cutaway front porch at the south end of the east elevation (façade). A narrow 4' by 16' shed-on-hip-roof extension to the original north (side) elevation appears to be an early addition. The circa 1997 addition measures approximately 28' N-S by 32' E-W. The addition is compatible with the original house in terms of its materials, details, and roof pitch; however, it has more than doubled the size of the original house.

The historic dwelling is supported by a low coursed sandstone foundation, and its exterior walls are clad with painted green horizontal weatherboard siding with painted cream white 1" by 4" corner boards. A painted cream color 1" by 8" board with a narrow wood water table separates the foundation from the horizontal weatherboard siding. A wide belt course of painted pale green variegated wood shingles separates the first and second stories on the façade, and variegated wood shingles also appear in the upper gable ends. The façade's upper gable end also displays a large gable ornament with a sunburst motif with colors of the rainbow. The original house's cross gable roof is steeply-pitched, and is covered with wood shingles. The eaves are boxed, with painted cream white trim, and gable dormers, each with a 1/1 double-hung sash window, are located at either end of the south-facing roof slope. A long, low-profile, shed-roofed dormer on the north-facing roof slope is penetrated by four 8-light windows. The house features an asymmetrical façade which faces toward Oak Street on the east elevation. The cutaway porch at the south end of the façade is approached by four wood steps, and features an open wood railing with turned balusters, turned columns with pierced brackets, and is topped by a small intersecting gable.

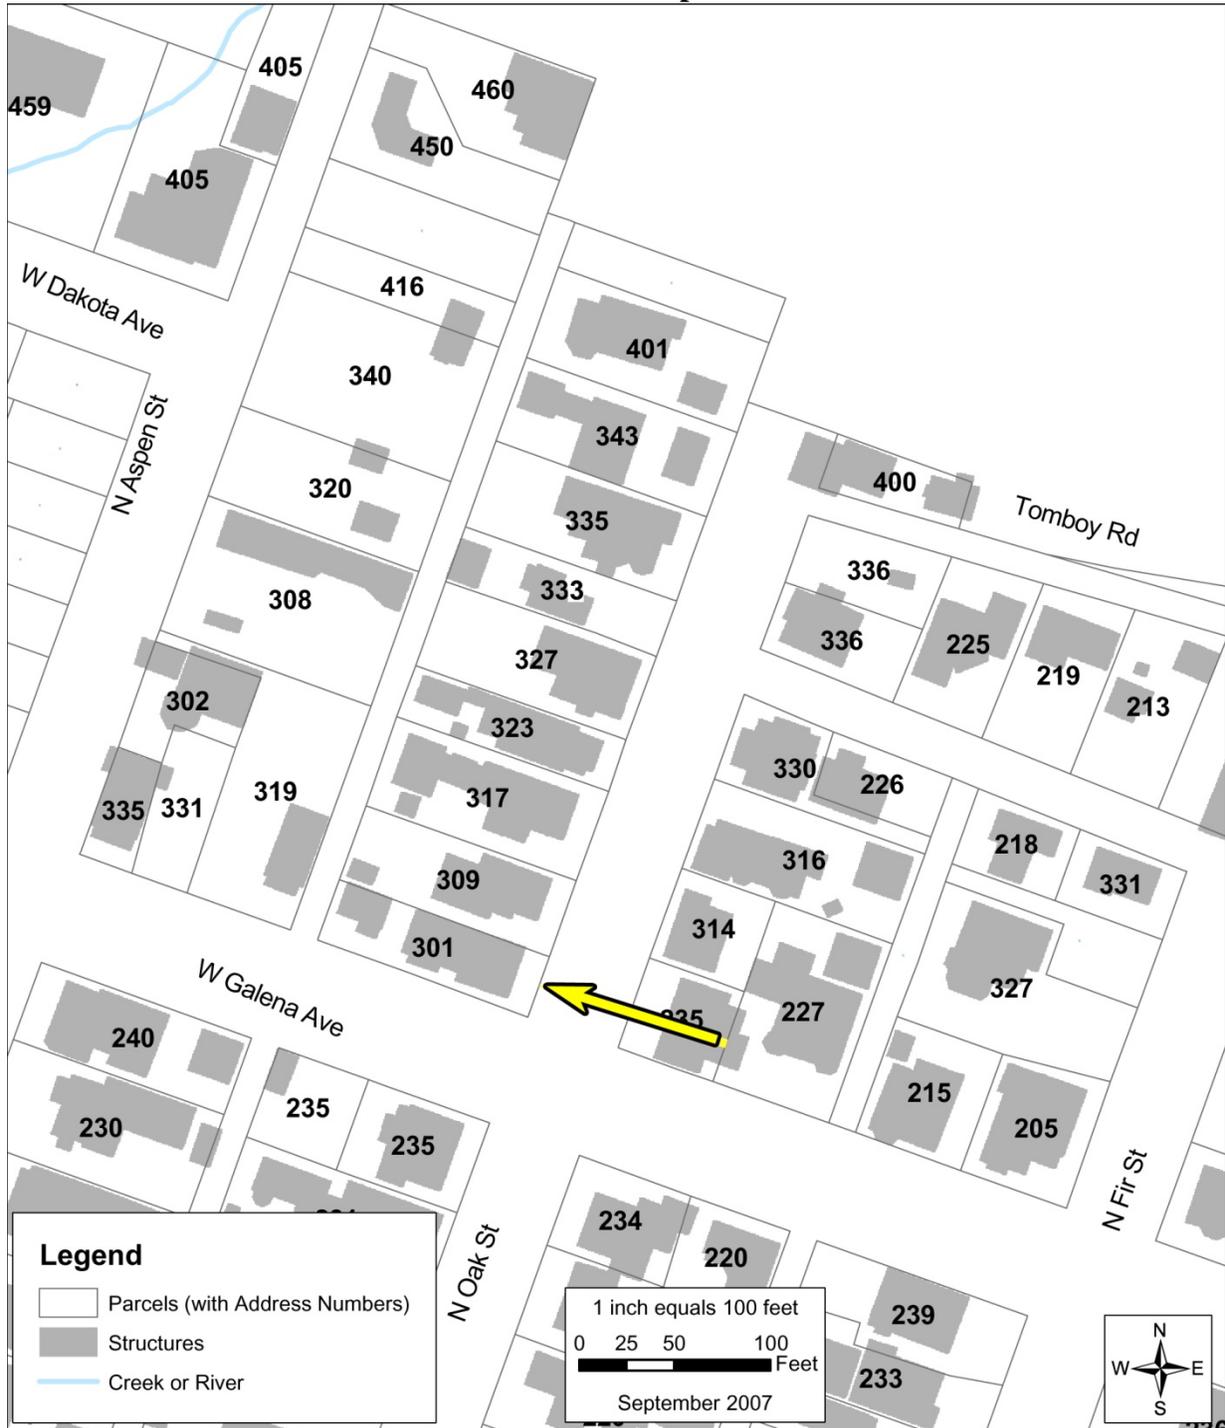
Sketch Map

23. Landscape or special setting features:
This property is located at the northwest corner of Oak Street and Galena Avenue. The small front yard and a narrow side yard along the south side of the house are nicely landscaped with native plants, shrubs and a coniferous tree. Low sandstone retaining walls parallel the sidewalks along Oak Street and Galena Avenue.
