COLORADO CULTURAL RESOURCE SURVEY

Architectural Inventory Form

- 1. Resource number: **5SM.1689/THAS.62**
- 2. Temporary resource number: **N/A**
- 3. County: **San Miguel**
- 4. City: **Telluride**
- 5. Historic Building Name: **Unknown**
- 6. Current Building Name: **Thornton House**
- 7. Building Address: **323 N. Oak Street**
- 8. Owner Name and Address: **Thornton, Stuart and Thornton, Elizabeth
P. O. Box 4230
Telluride, CO 81435**

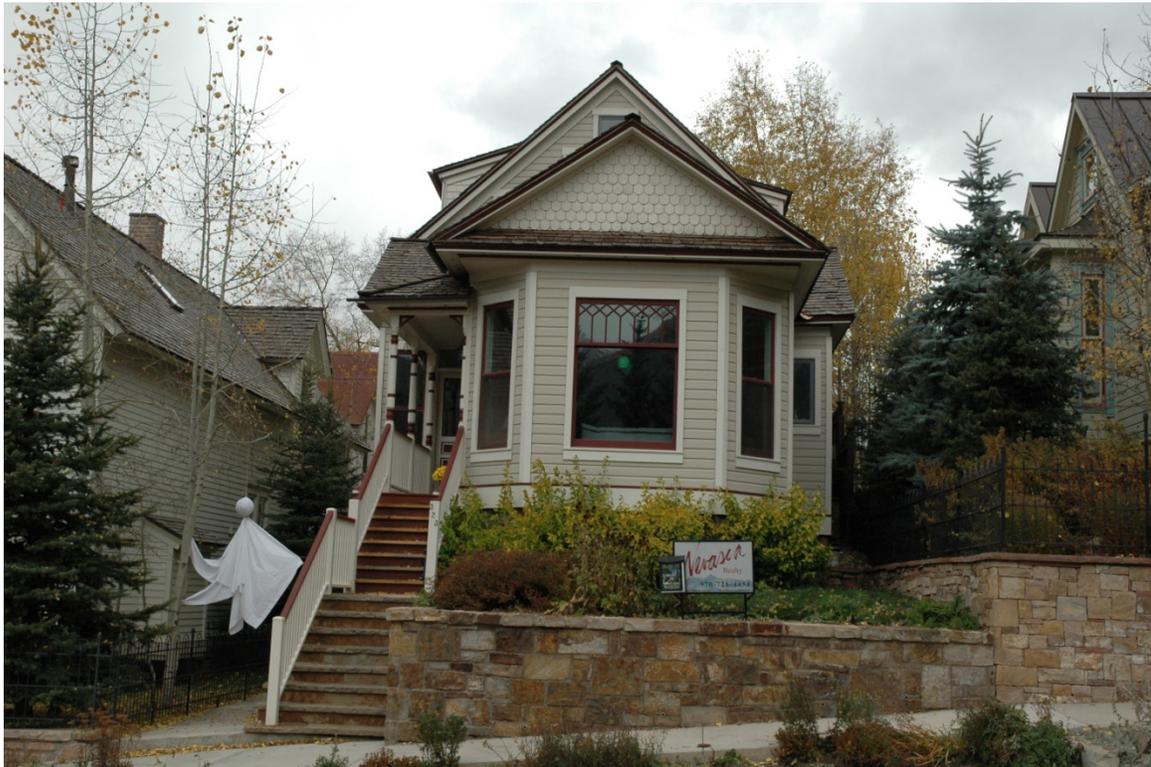
THLD RATING:	Primary - Supporting to District Shed - Supporting to District Garage/Secondary Residence – Non-Designated – New Construction
---------------------	--
