COLORADO CULTURAL RESOURCE SURVEY

**Architectural Inventory Form**

- 1. Resource number: **5SM.1691/THAS.61**
- 2. Temporary resource number: **N/A**
- 3. County: **San Miguel**
- 4. City: **Telluride**
- 5. Historic Building Name: **Unknown**
- 6. Current Building Name: **Tishman House**
- 7. Building Address: **333 (335) N. Oak Street**
- 8. Owner Name and Address: **Tishman, Daniel R. and Tishman, Sheryl C.  
6666 5th Avenue  
New York, NY 10102**

47. Photograph number(s):	<b>CD #7, Images 175-176; 184-187</b>	CDs filed at:	<b>Town of Telluride</b>
48. Report title:	<b>Town of Telluride Re-Survey of Historic Structures</b>		<b>Planning and Building Dept.</b>
49. Date(s):	<b>09/30/2009; revised 4/10/2012</b>		<b>113 West Columbia Avenue</b>
50. Recorder(s):	<b>Carl McWilliams</b> <b>Timothy Wilder</b>		<b>Telluride, CO 81435</b>
51. Organization:	<b>Cultural Resource Historians</b>		
52. Address:	<b>Dogwood Court</b> <b>Fort Collins, CO 80525</b>		
53. Phone number(s):	<b>(970) 493-5270</b>

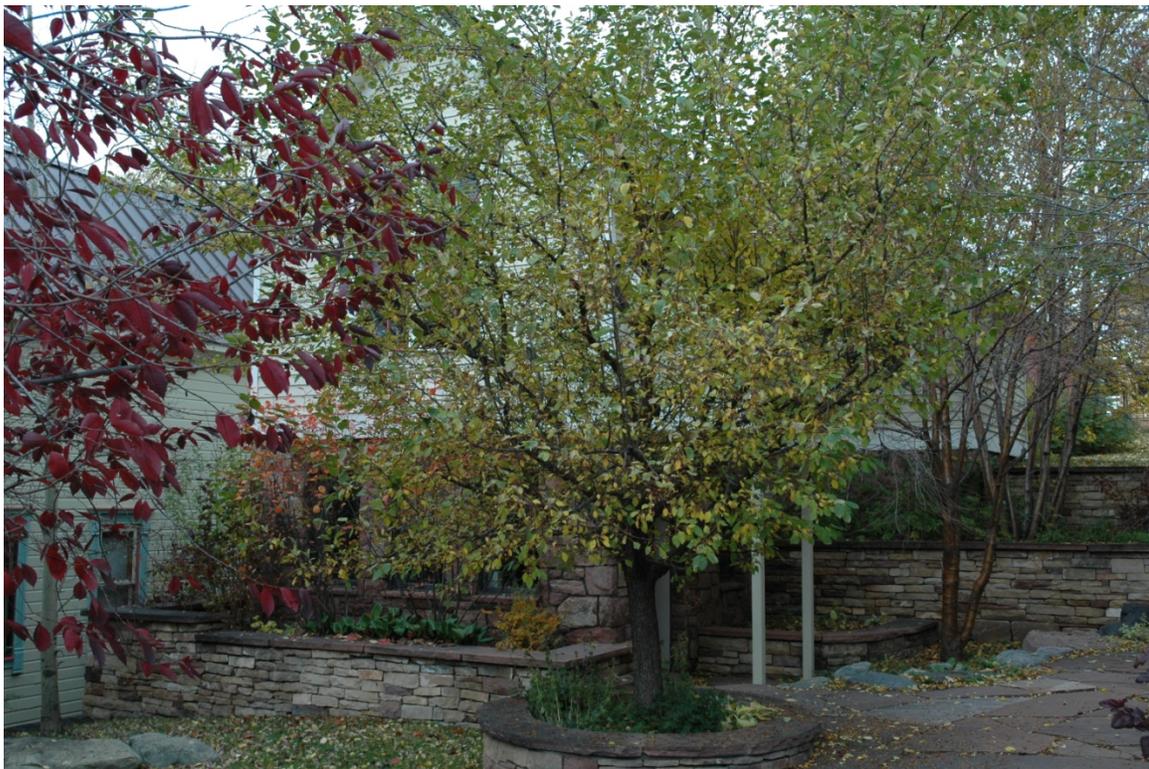
**This 1.5-story wood frame dwelling is supported by a high, non-historic, concrete foundation which has been faced with stone. A walk-out basement level, penetrated by three large 4-light windows, penetrates the east elevation (façade). The house's exterior walls are clad with painted cream yellow horizontal wood siding, with painted white 1" by 4" corner boards. The front gable roof is steeply-pitched, is covered with wood shingles, and has painted white boxed eaves. A shed-roofed extension is located on the south (side) elevation. A painted red wood-paneled front door, with one upper sash light, enters the ground level from a concrete porch at the east (front) end of the north (side) elevation. Another painted red wood-paneled door, with two upper sash lights, enters a low-pitched hip-roofed enclosed rear porch on the west elevation. A set of paired 4/4 double-hung sash windows, with painted red wood frames and painted white wood surrounds, penetrates the façade wall.**
