COLORADO CULTURAL RESOURCE SURVEY

Architectural Inventory Form

- 1. Resource number: **5SM.1693/THAS87**
- 2. Temporary resource number: **N/A**
- 3. County: **San Miguel**
- 4. City: **Telluride**
- 5. Historic Building Name: **Unknown**
- 6. Current Building Name: **Kees/Bonner House**
- 7. Building Address: **350 (400) N. Oak Street**
- 8. Owner Name and Address: **William Carl Kees and Susan Bonner
P.O. Box 931
Telluride, CO 81435**

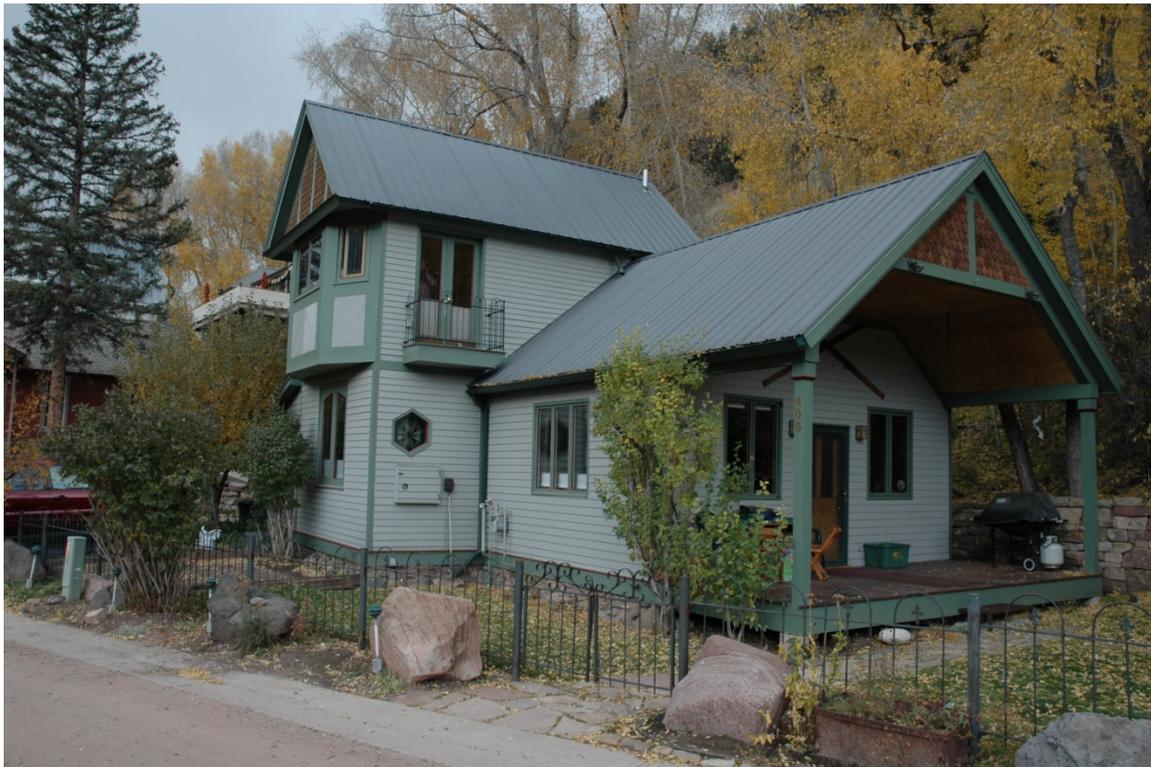
18. Roof configuration: **Gabled Roof/Front Gabled Roof**
19. Primary external roof material: **Metal Roof**
20. Special features: **Porch**
21. General architectural description:
This is a wood frame dwelling composed of a central 2.5-story gabled section, with a one-story gabled extension to the east elevation, and a one-story shed-roofed extension to the west elevation. The building is supported by a low uncoursed stone foundation, and its exterior walls are clad with painted pale green horizontal wood siding with painted olive green 1" by 4" corner boards. The gable and shed roofs are covered with metal roofing material, and the eaves are boxed with painted olive green boxed eaves. The house's windows are primarily non-historic casements, with painted olive green wood frames and surrounds. A non-historic stained natural brown wood-paneled door, with an upper sash light, enters the east elevation from a full-width front porch. This porch features a wood plank floor, painted olive green 6" by 6" wood post supports, and a gable roof. Another stained natural brown wood-paneled door, with two upper sash lights, enters the shed-roofed extension on the west elevation.

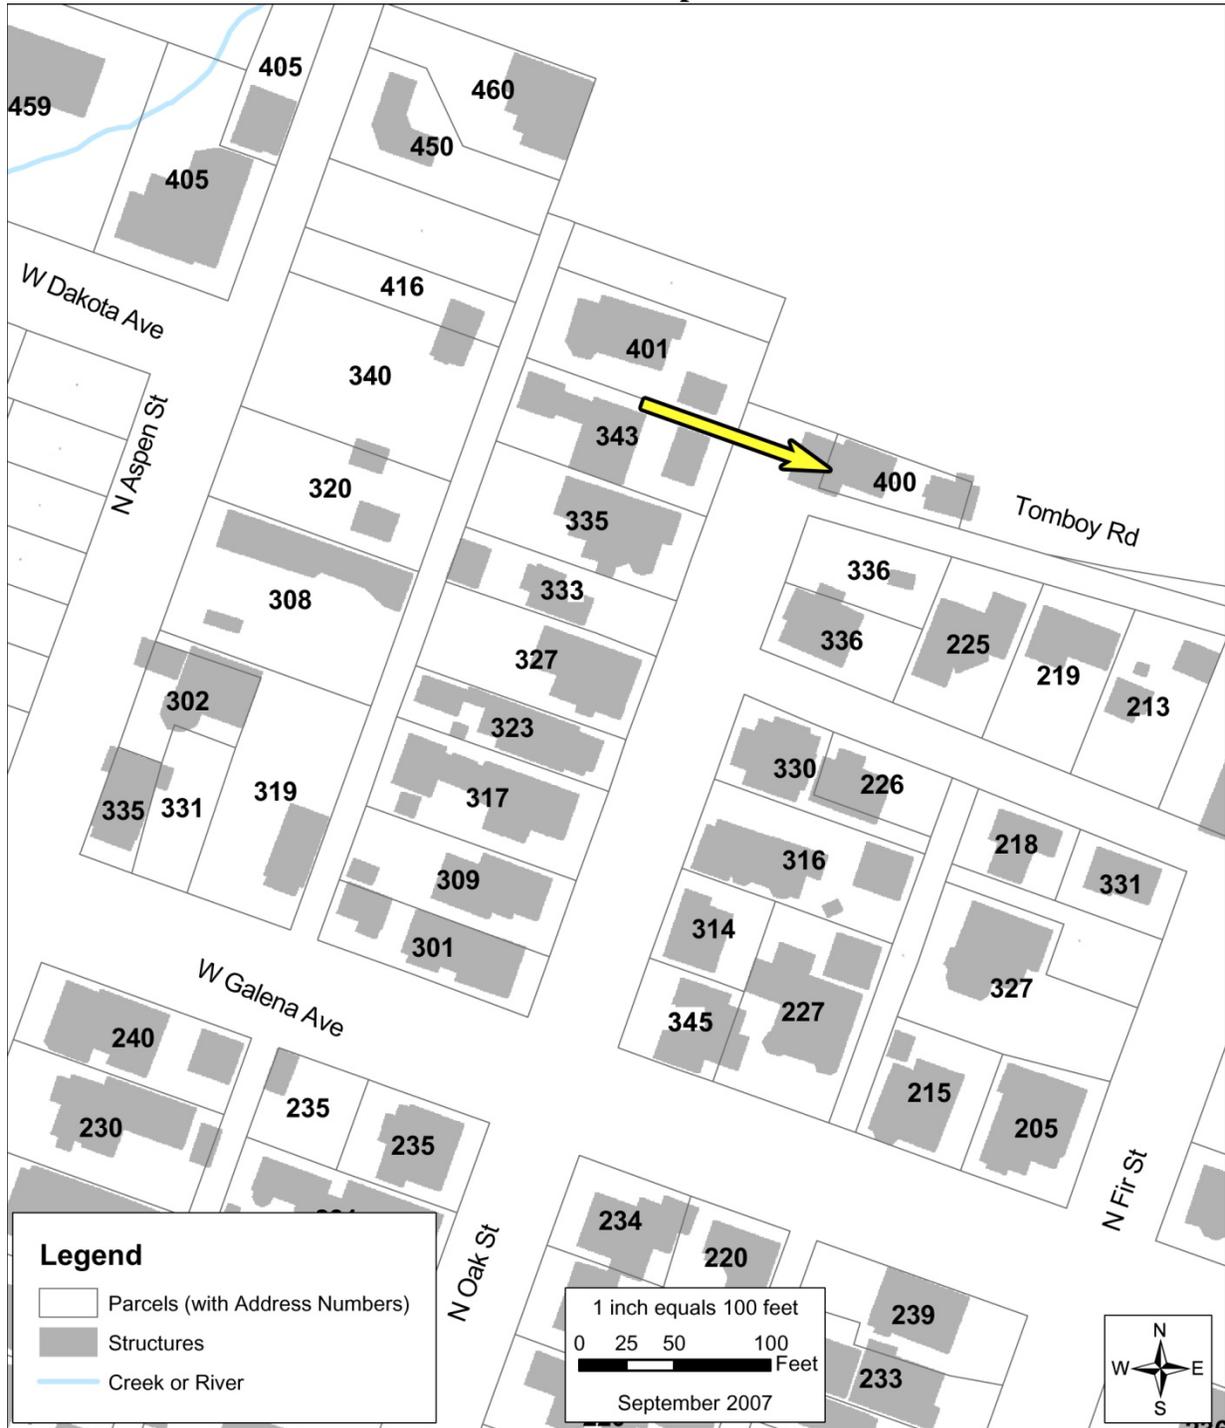
Sketch Map

22. Architectural style: **No Defined Style**
 Building type:
23. Landscape or special setting features:
This property is located at the northeast corner of N. Oak Street and Tomboy Road, at the northern edge of the Telluride National Historic Landmark District. A planted grass yard extends to the south and east of the dwelling. This property was surveyed with the address of 350 N. Oak Street in 1987; it now (in 2007) has the address of 400 N. Oak Street, or possibly 400 Tomboy Road.
