COLORADO CULTURAL RESOURCE SURVEY

Architectural Inventory Form

- 1. Resource number: **5SM.1626**
- 2. Temporary resource number: **N/A**
- 3. County: **San Miguel**
- 4. City: **Telluride**
- 5. Historic Building Name: **Unknown**
- 6. Current Building Name: **Gray House**
- 7. Building Address: **200 S. Oak Street**
- 8. Owner Name and Address: **Gray, William and Gray, Lynette
47 Prescott Avenue
Bronxville, NY 10708**

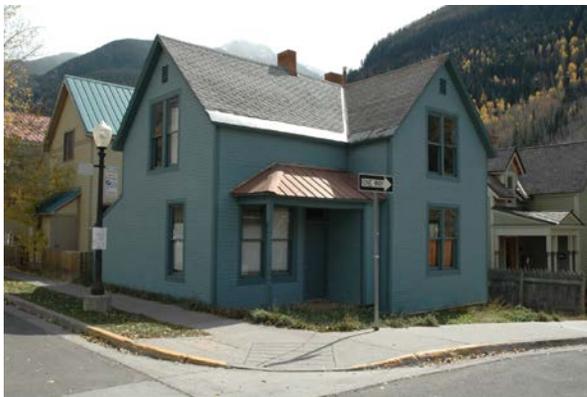
House at 200 S. Oak Street before renovation.
Photo August 2007

Note: The dwelling at 200 S. Oak Street was intensively surveyed in August 2007 during phase one of the Telluride Re-Survey of Historic Structures project. The dwelling was renovated subsequent to that time, with a new raised stone foundation, new exterior siding, a new metal roof, solar panels on the south-facing roof slope, some replacement windows, and a small intersecting gable above the existing hipped front porch roof. According to Town of Telluride building permit files, the owners used existing windows to the extent possible, working with Phoenix Window Restoration of Denver. Existing foundation stones were reused as well. The windows' overall dimensions and configuration are unchanged. The historic siding was retained as sheathing beneath the new exterior siding which is an in-kind replacement. This form's architectural description (fields 14-21 below) relate to the dwelling's appearance as it existed in August 2007. The form's eligibility evaluation (fields 37-46 below) relates to the dwelling as it exists in April 2012, following the renovation.

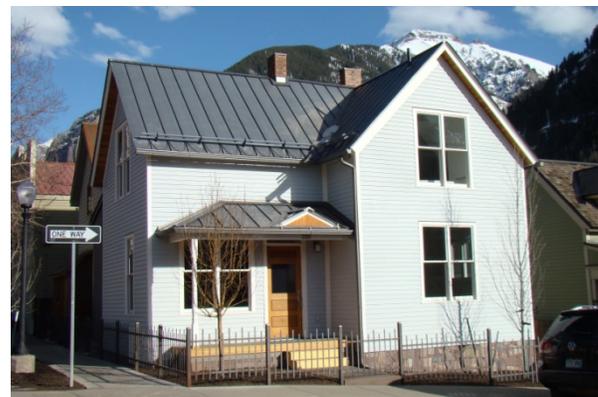
House at 200 S. Oak Street after renovation.
Photo March 2012
