COLORADO CULTURAL RESOURCE SURVEY

Architectural Inventory Form

- 1. Resource number: **5SM.1629/THAS.166**
- 2. Temporary resource number: **N/A**
- 3. County: **San Miguel**
- 4. City: **Telluride**
- 5. Historic Building Name: **Unknown**
- 6. Current Building Name: **Watenpaugh House**
- 7. Building Address: **228 (230) S. Oak Street**
- 8. Owner Name and Address: **Jane Watenpaugh  
P. O. Box 702  
228 S. Oak Street  
Telluride, CO 81435**

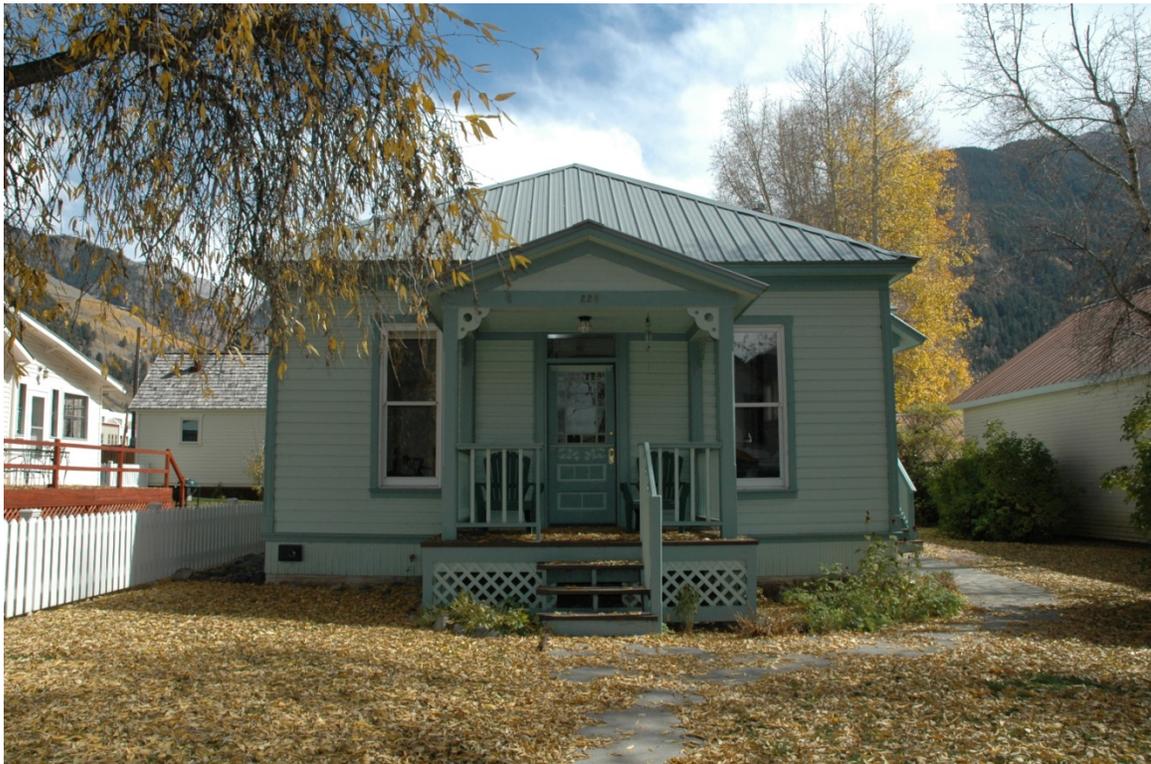
**This is a single-story, wood frame, hip-roofed dwelling, with a hip-roofed addition to the east (rear) elevation. The house is supported by a low coursed sandstone foundation, faced with painted green beadboard. The exterior walls are clad with painted green horizontal weatherboard siding, with painted teal 1" by 4" corner boards. The roof is covered with metal roofing material, and the eaves are boxed with painted teal wood trim. The dwelling's symmetrical façade faces toward Oak Street on the west elevation. A painted green wood-paneled front door, with Queen Anne upper sash lights, and with a transom light, enters the center of the façade from a 4-step porch. This porch features a wood plank floor, an open wood railing, painted green square wood posts, and a gable roof. The porch is flanked on either side by a 1/1 double-hung sash window, with a painted green wood surround, which penetrate the façade wall. Windows elsewhere are also predominantly 1/1 double-hung sash with painted green wood surrounds. A painted teal and green wood-paneled door, with one upper sash light and with a transom light enters the addition on the north elevation. This door (which faces west) is approached by a 4-step wood porch covered by a gable hood.**
