COLORADO CULTURAL RESOURCE SURVEY

Architectural Inventory Form

- 1. Resource number: **5SM.1690**
- 2. Temporary resource number: **N/A**
- 3. County: **San Miguel**
- 4. City: **Telluride**
- 5. Historic Building Name: **Unknown**
- 6. Current Building Name: **Digiacommo House**
- 7. Building Address: **327 N. Oak Street**
- 8. Owner Name and Address: **Digiacommo, Nicholas Family Trust
P. O. Box 1656
Telluride, CO 81435**

47. Photograph number(s):	CD #7, Images 172-174, 188-190	CDs filed at:	Town of Telluride
48. Report title:	Town of Telluride Re-Survey of Historic Structures		Planning and Building Dept.
49. Date(s):	10/15/2007; revised 4/10/2012		113 West Columbia Avenue
50. Recorder(s):	Carl McWilliams		Telluride, CO 81435
	Timothy Wilder		
51. Organization:	Cultural Resource Historians		
52. Address:	Dogwood Court		
	Fort Collins, CO 80525		
53. Phone number(s):	(970) 493-5270

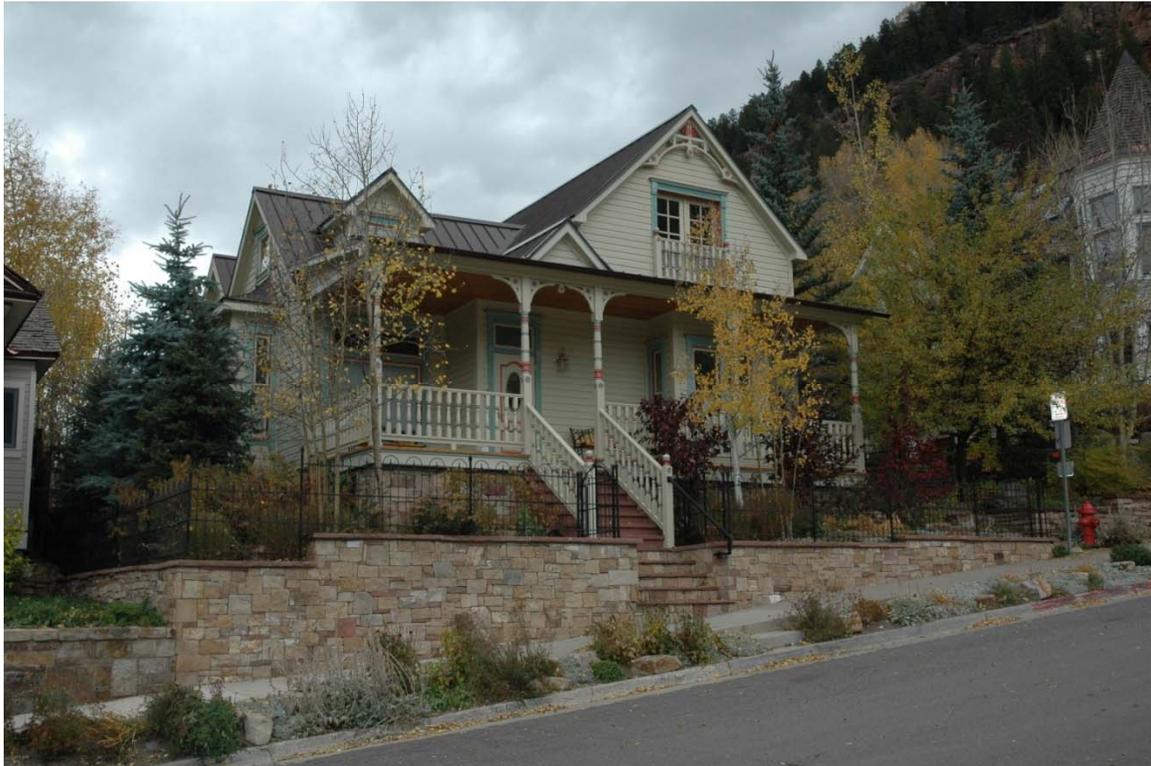
THLD RATING:	Noncontributing Without Qualifications
---------------------	---

21. General architectural description:
This is a .5-story, turn-of-the-twentieth-century, wood frame dwelling, with a modest, circa 2003, addition to the west (ear) elevation, and non-historic circa mid-1980s front porch. The original portion features a cross-gabled, T-shaped, plan, and measures approximately 34' N-S (across) by 50' E-W (deep). The addition measures 15' N-S by 21' E-W. The original house is supported by a low coursed sandstone foundation, and the exterior walls are clad with painted beige horizontal wood siding with 1" by 4" corner boards. The cross gable roof is steeply-pitched, and is covered with metal roofing material. The eaves are boxed with painted beige wood trim, and a gabled dormer with a 1/1 double-hung sash window overlooks the façade on the east elevation. A non-historic gable ornament is located in the façade's upper gable end. A non-historic painted beige wood-paneled door, with painted salmon color wood trim, an oval light, and a transom light, enters the façade from the non-historic front porch. This L-shaped, full-width, front porch is approached by five flagstone steps and seven wood steps, and features a wood plank floor, an open wood railing with turned balusters, turned columns with brackets, and a low-pitched hip roof with an intersecting gable over the entry. A box bay, with four 1/1 double-hung sash windows, overlooks the front porch to the north of the entry door. A hip-roofed bay is located on the south elevation. Windows elsewhere are predominantly 1/1 double-hung sash with painted beige wood frames and painted turquoise fluted architrave surrounds. The rear addition is covered by a shed roof.

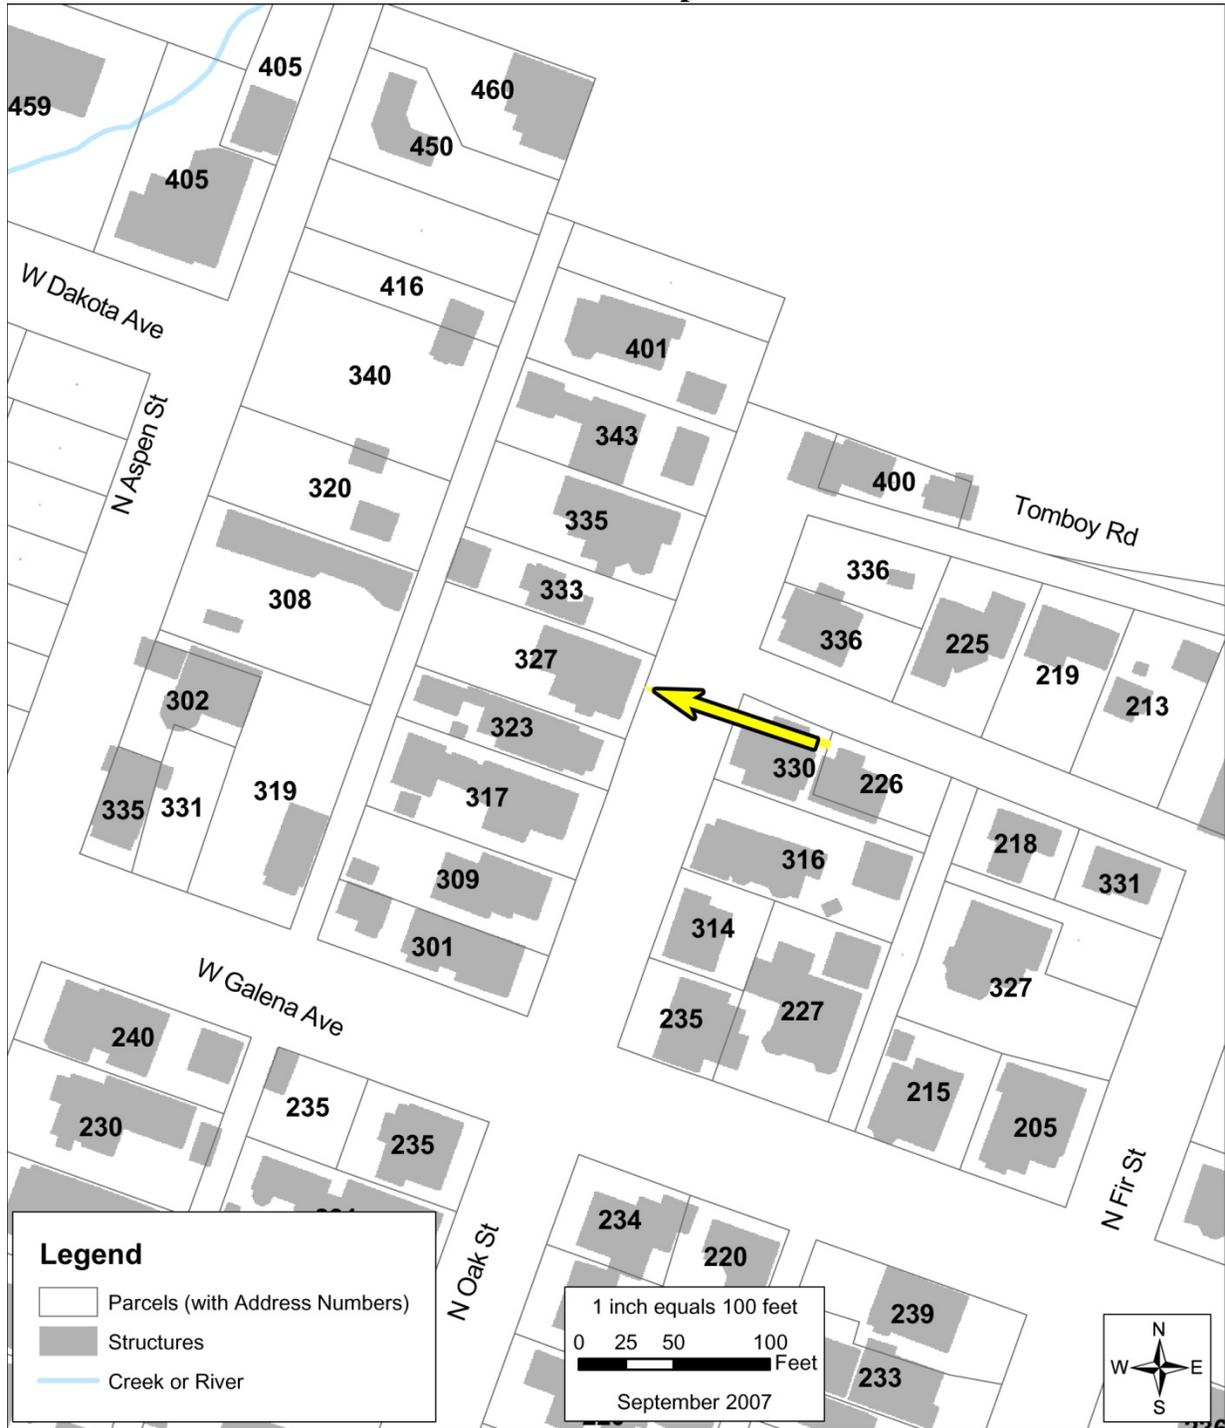
Sketch Map

23. Landscape or special setting features: **This property is located on the west side of North Oak Street in the block north of Galena Avenue, at a point where N. Oak Street and Gregory Avenue form a T-intersection. The front yard is nicely landscaped with stands of aspen trees. A stone retaining wall parallels the front sidewalk.**

Garage
<p>A 1.5-story garage is located adjacent to the alley at the rear of the property. This building rests on a concrete foundation, and its exterior walls are clad with stained dark brown vertical wood siding. The front gable roof is steeply-pitched, and is covered with rusticated corrugated metal roofing material. A garage door, made of stained dark brown vertical wood siding, is located on the south elevation. The garage features 4-light awning windows, with painted red wood frames.</p>
