COLORADO CULTURAL RESOURCE SURVEY

Architectural Inventory Form

- 1. Resource number: **5SM.1715**
- 2. Temporary resource number: **N/A**
- 3. County: **San Miguel**
- 4. City: **Telluride**
- 5. Historic Building Name: **N/A**
- 6. Current Building Name: **Jorgensen House**
- 7. Building Address: **210 N. Aspen Street**
- 8. Owner Name and Address: **The Jorgensen Family Limited Partnership
4500 Neva Road
Longmont, CO 80503**

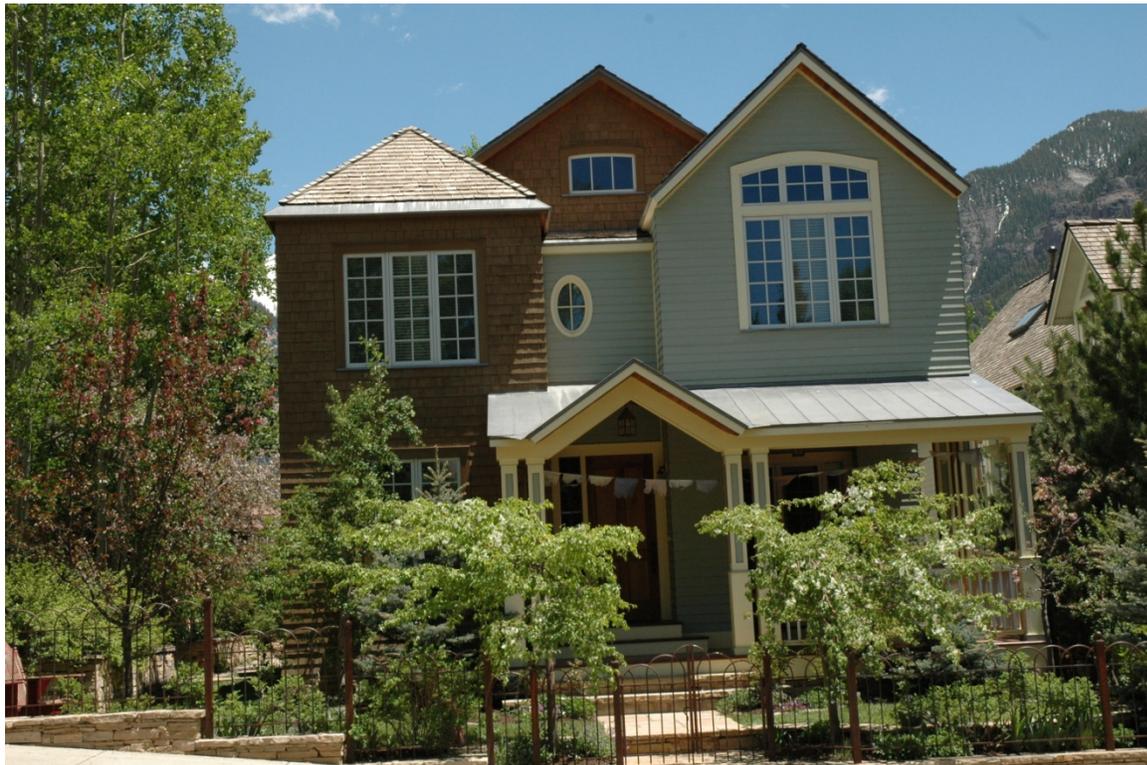
21. General architectural description:
This is a relatively large 2½-story dwelling. It rests on a poured concrete foundation, faced with stone above grade. Portions of the exterior walls are clad with painted green horizontal wood siding, while elsewhere the exterior walls are clad with square-cut wood shingle siding. The house is covered by multiple gabled and hipped roof forms, with wood shingles and boxed eaves. The asymmetrical facade faces Aspen Street on the west elevation. A stained natural brown wood-paneled door, with a flanking leaded glass sidelight, enters the facade from an L-shaped front porch. The porch features a painted red tongue-in-groove wood floor, a painted cream white open wood railing, painted green and white square columns, and a shed roof with an intersecting gable over the stairs. A stained natural brown glass-in-wood-frame door enters the east (rear) elevation from a stone terrace. An elevated second story wood deck on the east elevation is accessed by an exterior wooden staircase. A set of paired glass-in-wood-frame doors, with flanking sidelights, and covered by a segmental arch, open onto the deck from the second story. The home's windows appear primarily to be casements.

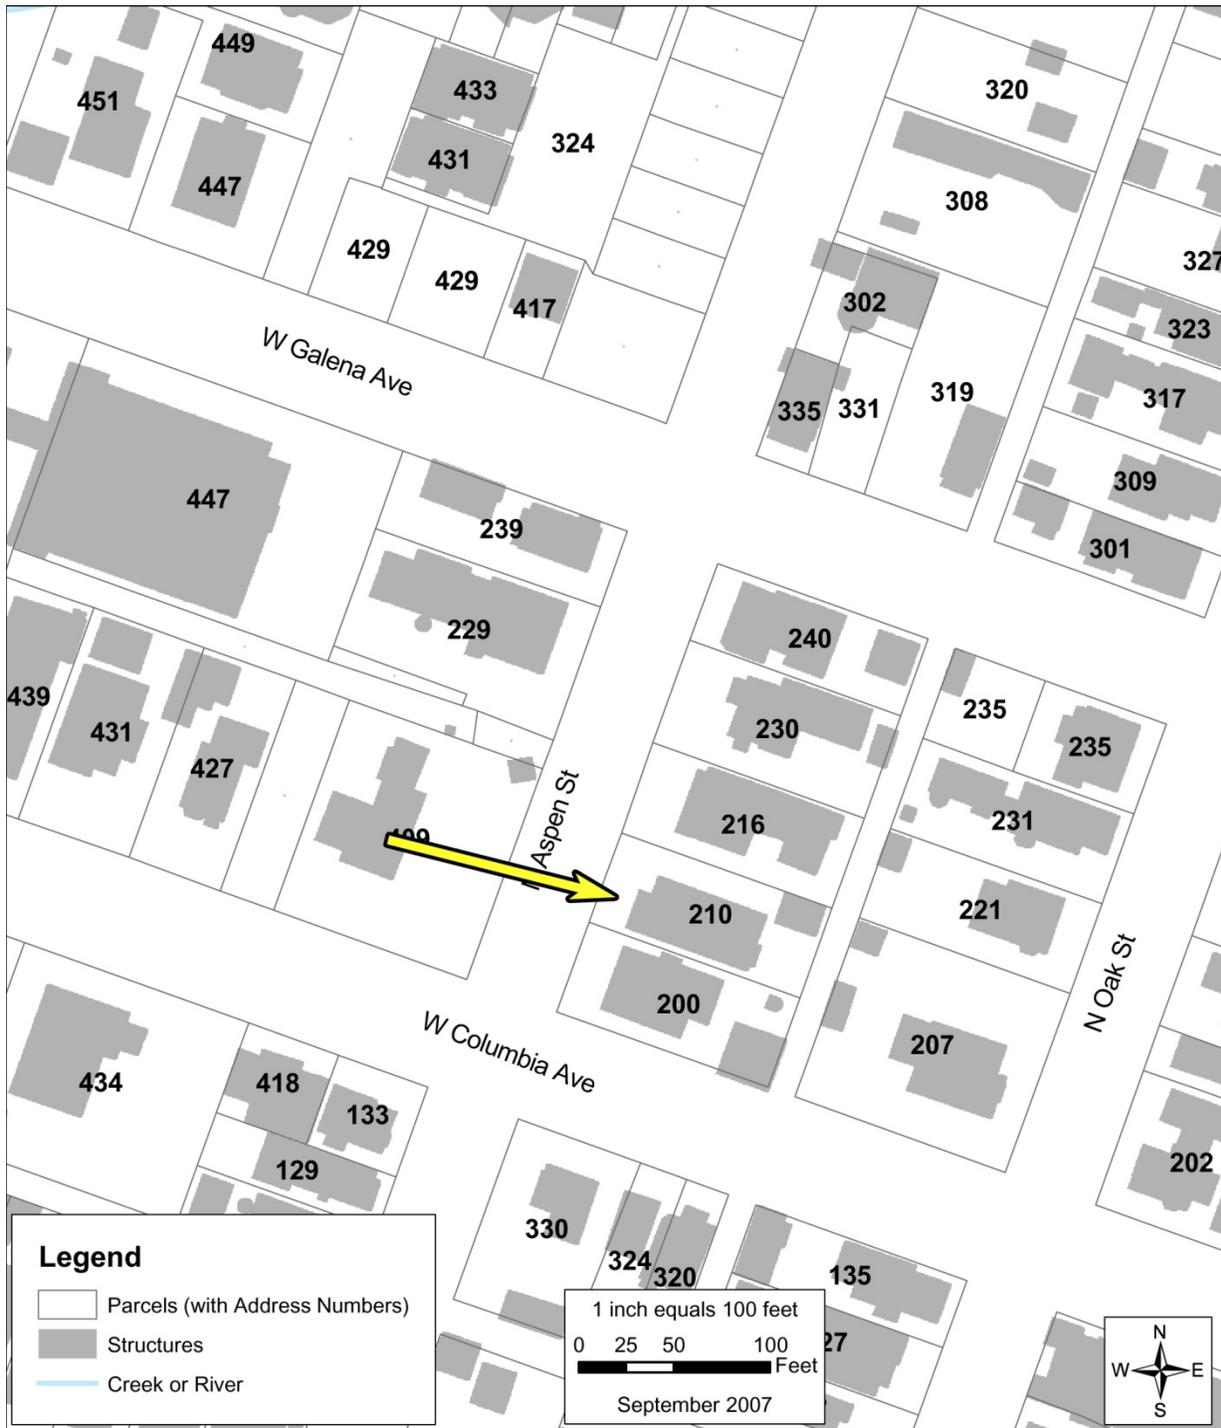
Sketch Map

22. Architectural style: **Modern Movements**
 Building type:
23. Landscape or special setting features:
This is the second house north of Columbia Avenue on the east side of N. Aspen Street. A modern metal fence with cannonball finials extends along the top of a sandstone retaining wall which parallels the front sidewalk. A small planted grass front yard is nicely landscaped with native plants, flowers, cherry trees, and spruce trees.
