COLORADO CULTURAL RESOURCE SURVEY

Architectural Inventory Form

| 5. Historic Building Name: | Merchandise Warehouse; Electrical Supply Warehouse | | 477901137040 |
| 7. Building Address: | 225/227 S. Pine Street | | 477901137043 |

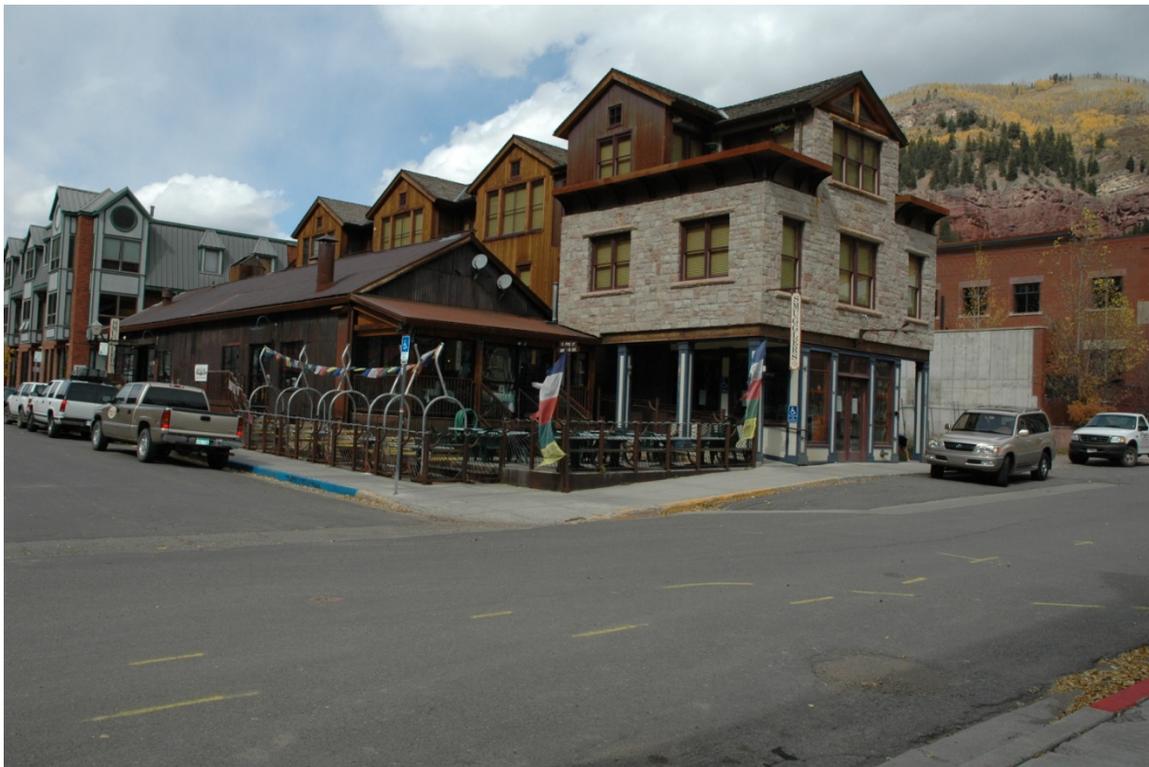
18. Roof configuration: **Gabled Roof**
19. Primary external roof material: **Metal Roof**
20. Special features: **Not Applicable**
21. General architectural description:
The historic warehouse on this property has been adaptively incorporated into dining and kitchen space for the Smugglers Brewery Restaurant and Bar. Built prior to 1893, the warehouse is a long, rectangular-shaped building. Its south elevation fronts directly onto the concrete sidewalk which parallels San Juan Avenue, while its east elevation is set back some distance from South Pine Street. The main part of the building is covered by a gable roof; however, there is a small shed roofed extension on the east elevation. The building's walls are covered with rusticated corrugated metal. This historic building is essentially now part of the Smugglers Brewery complex, and the associated San Juan Warehouse Condos. complex which now occupies the northwest corner of San Juan Avenue and S. Pine Street.
