COLORADO CULTURAL RESOURCE SURVEY

Architectural Inventory Form

- 1. Resource number: **5SM.1628/THAS.161&167**
- 2. Temporary resource number: **N/A**
- 3. County: **San Miguel**
- 4. City: **Telluride**
- 5. Historic Building Name: **Unknown**
- 6. Current Building Name: **Jackman House**
- 7. Building Address: **222 S. Oak Street**
- 8. Owner Name and Address: **Oak Street Investments LLC
151 S Old Woodward Ave, STE 400
Birmingham, MI 48009**

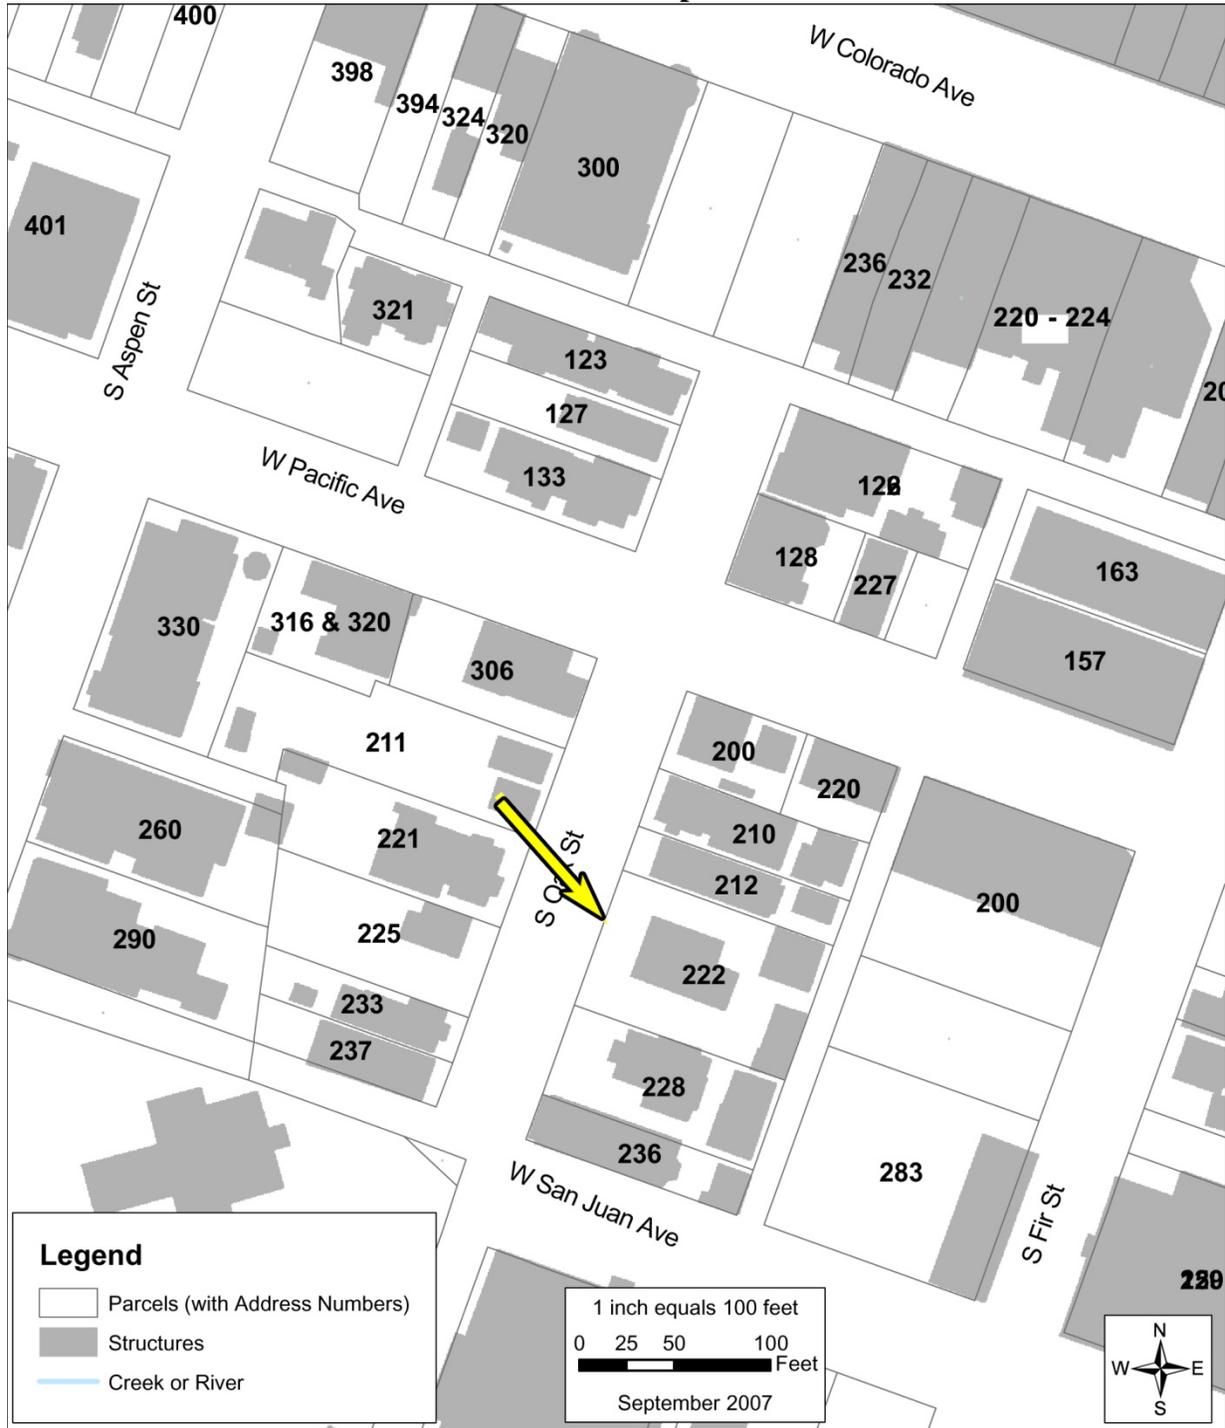
Sketch Map

This property is located on the east side of South Oak Street in the block between Pacific and San Juan Avenues. The house is set back farther from the street, compared to other nearby houses, and the front yard is enclosed by a painted white picket fence.

A modern 1.5-story garage, perhaps with living quarters in the upper half story, is located adjacent to the alley near the rear northeast corner of the property. This is a rectangular-shaped wood frame building supported by a concrete slab foundation. It has painted white horizontal exterior wood siding, and a steeply-pitched front gable roof. A large shed-roofed dormer is located on the south-facing roof slope. Two garage doors, beneath a pent roof, open toward the alley on the east elevation.
