COLORADO CULTURAL RESOURCE SURVEY

Architectural Inventory Form

| 5. Historic Building Name: | Bartine House (probably) | | |
| 7. Building Address: | 469 W. Pacific Avenue | | |

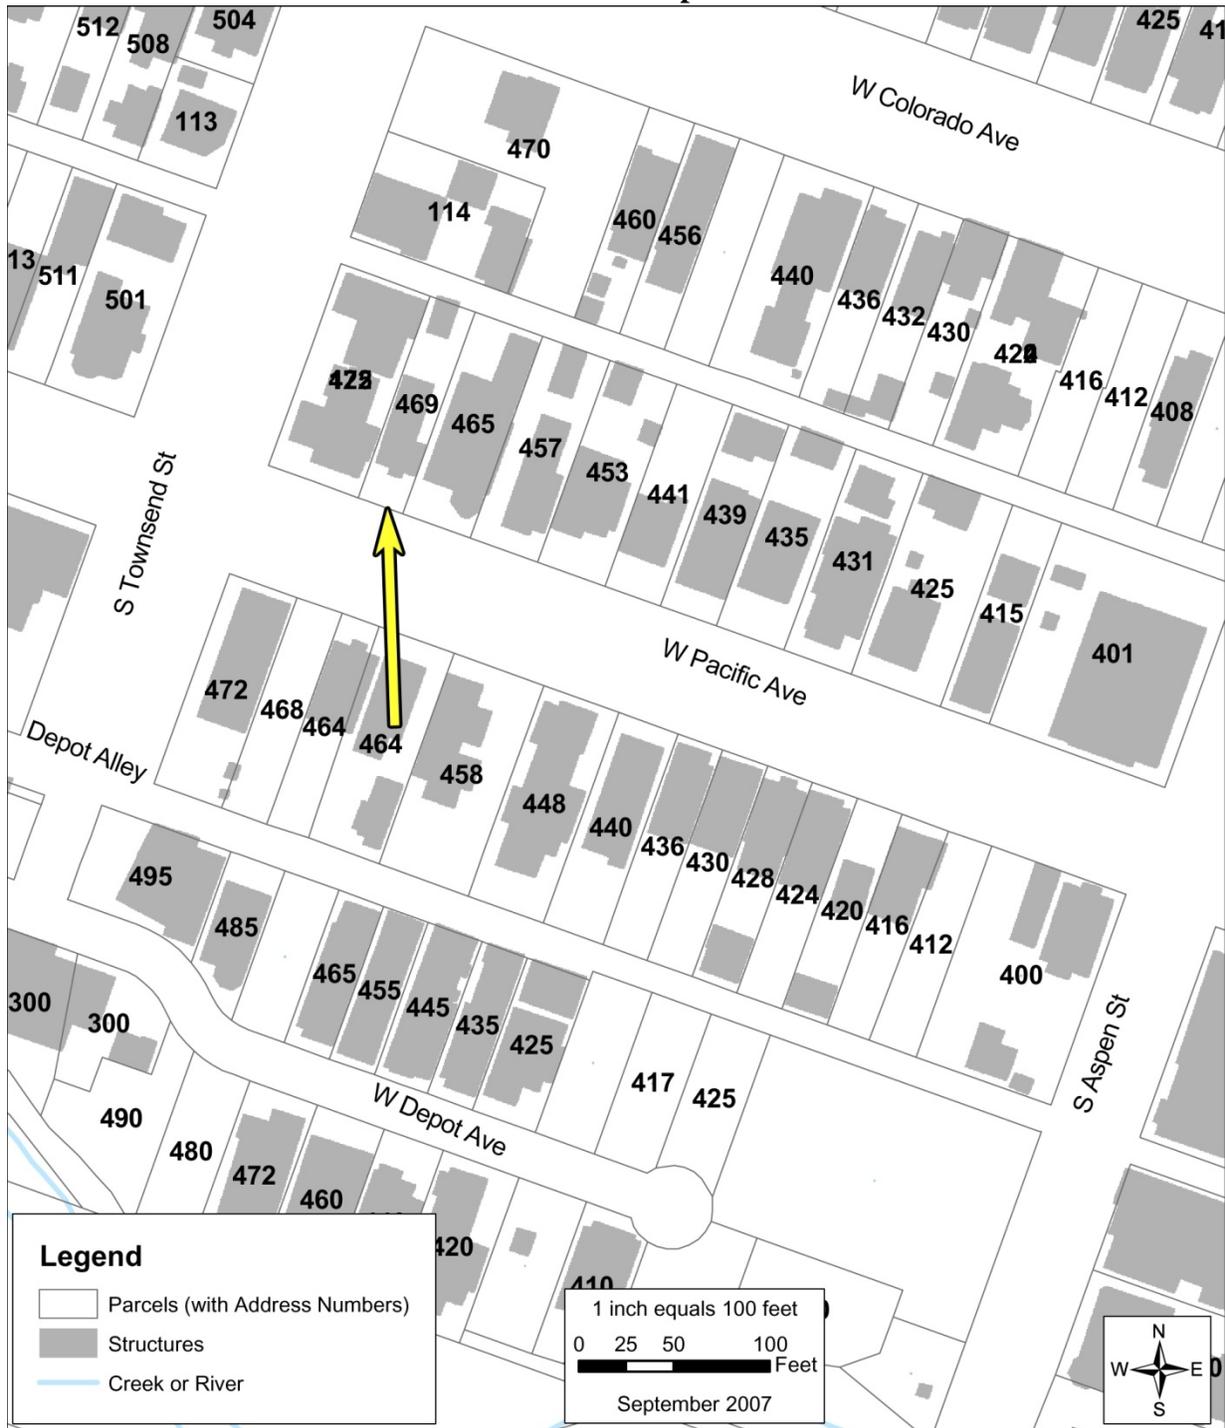
Sketch Map

This property is located on the north side of West Pacific Avenue in the block between Aspen and Townsend Streets. A small front yard is defined by a coursed stone kneewall along the front sidewalk. A narrow strip of land between the front sidewalk and the street was scheduled to be sodded with grass and landscaped in the fall of 2007.

Secondary Residence
<p>A secondary residence has recently been constructed on the back half of the property. (A shed (THAS #203) which had been located on the back half of the lot has been razed.) The new secondary residence is a 2.5-story wood frame building, supported by a concrete foundation, and with stained brown vertical wood plank walls. A second story shed-roofed extension to the north elevation, though, is clad with metal panels, with a carport below. The building's main 2.5-story portion is covered by a steeply-pitched gable roof, with metal roofing material. A balcony is incorporated into the east-facing roof slope.</p>
