COLORADO CULTURAL RESOURCE SURVEY

Architectural Inventory Form

- 1. Resource number: **5SM.1770**
- 2. Temporary resource number: **N/A**
- 3. County: **San Miguel**
- 4. City: **Telluride**
- 5. Historic Building Name: **St. Patrick's Church**
- 6. Current Building Name: **St. Patrick's Church**
- 7. Building Address: **301 N. Spruce Street**
- 8. Owner Name and Address: **Bishop of Pueblo Saint Patrick Church  
1001 Grand Avenue  
Pueblo, CO 81003**

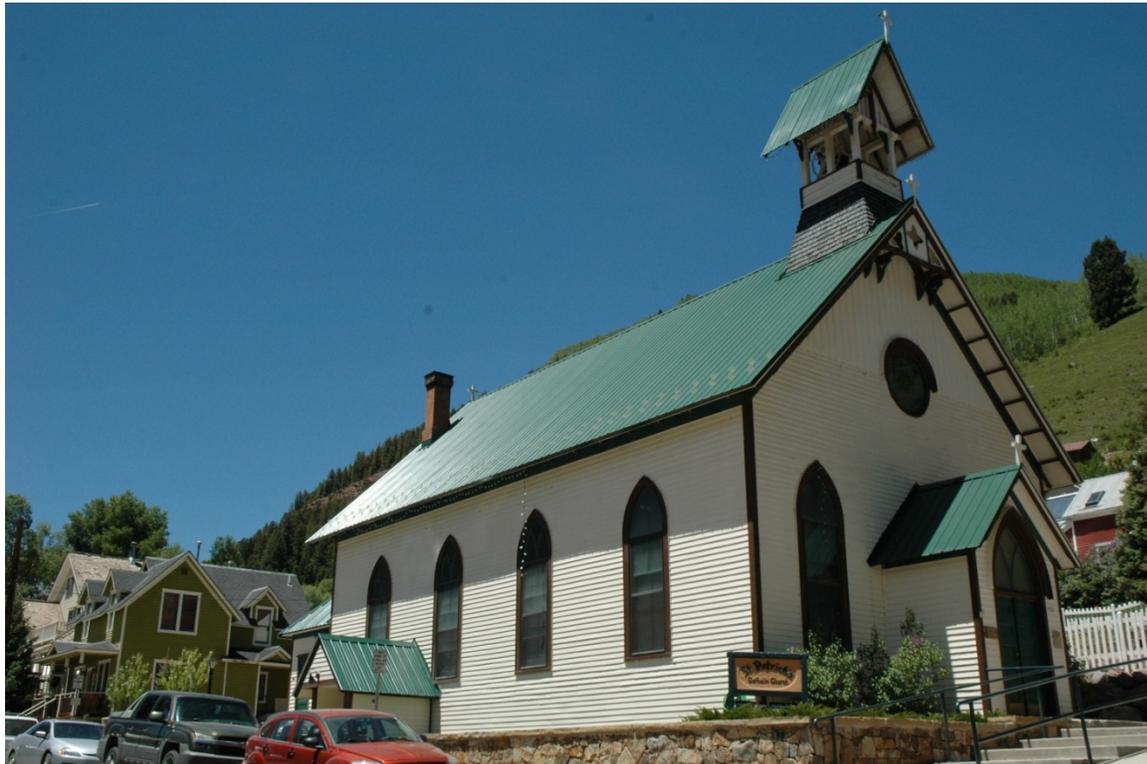
21. General architectural description:  
**St. Patrick's Catholic Church is a tall 1½-story wood frame building which measures 31½' N-S (across) by 50' E-W (deep). There is also a single-story hipped-roof extension on the west (rear) elevation which measures 28½' N-S by 10' E-W, and an enclosed gabled vestibule centered on the east elevation which measures 10' N-S by 6' E-W. The building's stone foundation above grade is covered by metal skirting, while its exterior walls are clad with painted cream yellow color horizontal wood siding with painted brown 1" by 6" corner boards. Painted cream yellow vertical wood siding appears in the facade's upper gable end on the east elevation. The church roof is a steeply-pitched front gable, with metal roofing material, and with painted brown sculptured rafter ends beneath the eaves. A distinctive gabled bell tower is at the front end of the roof peak. The base of the bell tower is clad with wood shingles, while the upper portion has painted cream yellow horizontal wood siding, and chamfered 4" by 4" vertical wood posts which support a steeply-pitched gabled roof over the bell. A painted white cross finial is at the apex of the bell tower's roof. An ornate, pierced, gable ornament is in the facade's upper gable end, just below the bell tower. A red brick chimney, with a corbelled cap, is near the east end of the south-facing roof slope. A set of paired, painted green, wood-paneled doors, with a gothic-arched transom light with tracery, enter the vestibule on the facade. Another painted white cross finial is at the apex of the vestibule's roof. The main 1½-story portion of the church features symmetrically arranged gothic-arched windows with painted green wood frames, painted brown wood surrounds, and with stained glass and tracery. Four gothic-arched windows**

penetrate the north elevation; four others penetrate the opposite south elevation; two others flank the vestibule on the facade. A set of concrete and metal steps descend to a basement-level door beneath a gabled covering on the south elevation. A green metal-paneled door, with one upper sash light, enters the hipped-roof extension on the west elevation. A painted green wood-paneled door, with five cross panels, enters the south elevation of the hipped-roof extension. There are two facade plaques. One is inscribed "ST. PATRICK'S CHURCH 1896." The other plaque provides historical and descriptive narratives.
