COLORADO CULTURAL RESOURCE SURVEY

Architectural Inventory Form

- 1. Resource number: **5SM.1774**
- 2. Temporary resource number: **N/A**
- 3. County: **San Miguel**
- 4. City: **Telluride**
- 5. Historic Building Name: **Taylor House, Wood House**
- 6. Current Building Name: **Bayleaf Holdings LLC House**
- 7. Building Address: **320 N. Spruce Street**
- 8. Owner Name and Address: **Bayleaf Holdings, LLC  
P. O. Box 1827  
Telluride, CO 814351827**

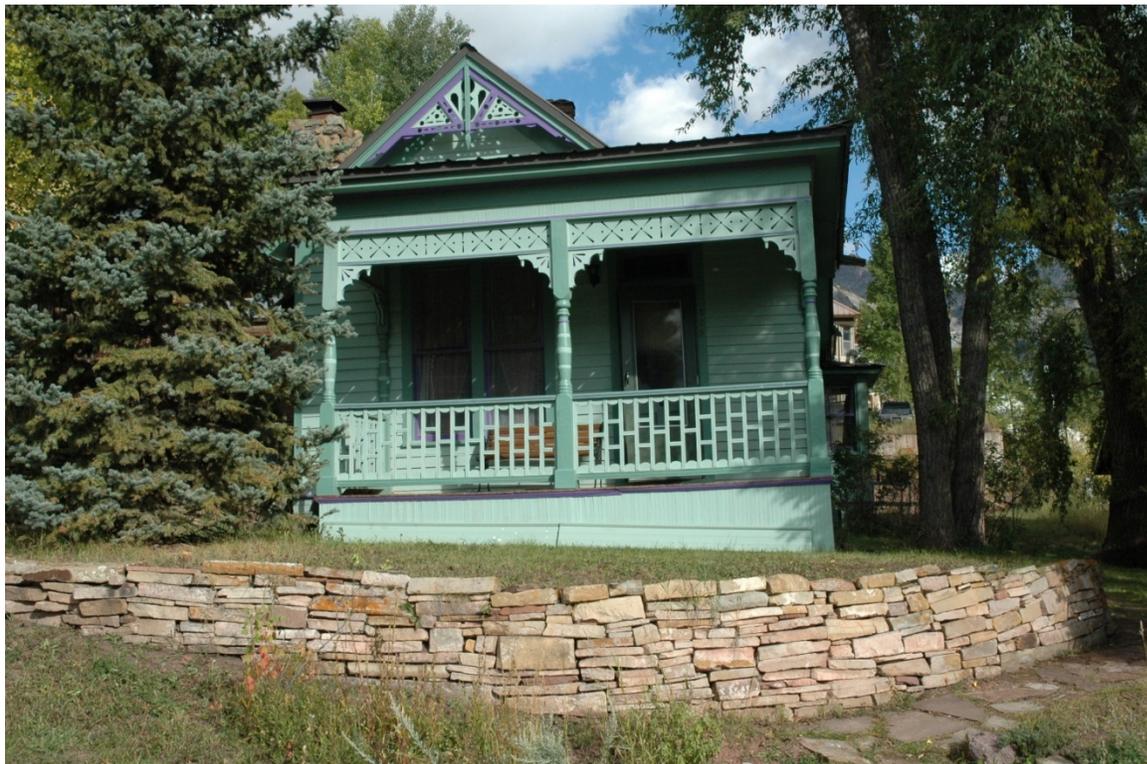
21. General architectural description:  
**This single-story wood frame dwelling features a main cross gabled section, which measures 19' N-S (across) by 40' E-W (deep), and a shed-roofed extension to the east (rear) elevation which measures 18½-feet N-S by 8' E-W. The house is supported by an unpainted sandstone foundation, while its exterior walls are clad with painted light green horizontal wood siding with painted dark green 1" by 4" corner boards. The cross gabled roof is steeply-pitched, with metal roofing material and painted green boxed eaves. Ornate gable ornaments are in the upper gable ends on the west, south, and east elevations. There are two chimneys: one is a stone fireplace chimney near the west end of the north elevation; the other is a red brick chimney on the ridge. The asymmetrical facade faces Spruce Street on the east elevation. A wood-paneled front door is painted green with purple trim. This door has one upper sash light, it is covered by a green metal storm door, and it enters the facade from a 5-step open front porch. The porch features a tongue-in-groove wood floor, a painted green open wood railing, turned columns with pierced brackets, a pierced frieze, and a low-pitched hipped porch roof. The underside of the porch is finished with bead board skirting. A painted green wood-paneled door, with one upper sash light, and covered by a green metal storm door, enters the shed-roofed extension on the east elevation. A hipped-roof boxed bay, with a single-light fixed-pane window and flanking 1.1 double-hung sash windows, is at the east end of the south elevation. The north elevation is penetrated by an oculus window. Windows elsewhere are primarily 1/1 double-hung sash with painted purple wood frames and painted green wood surrounds.**

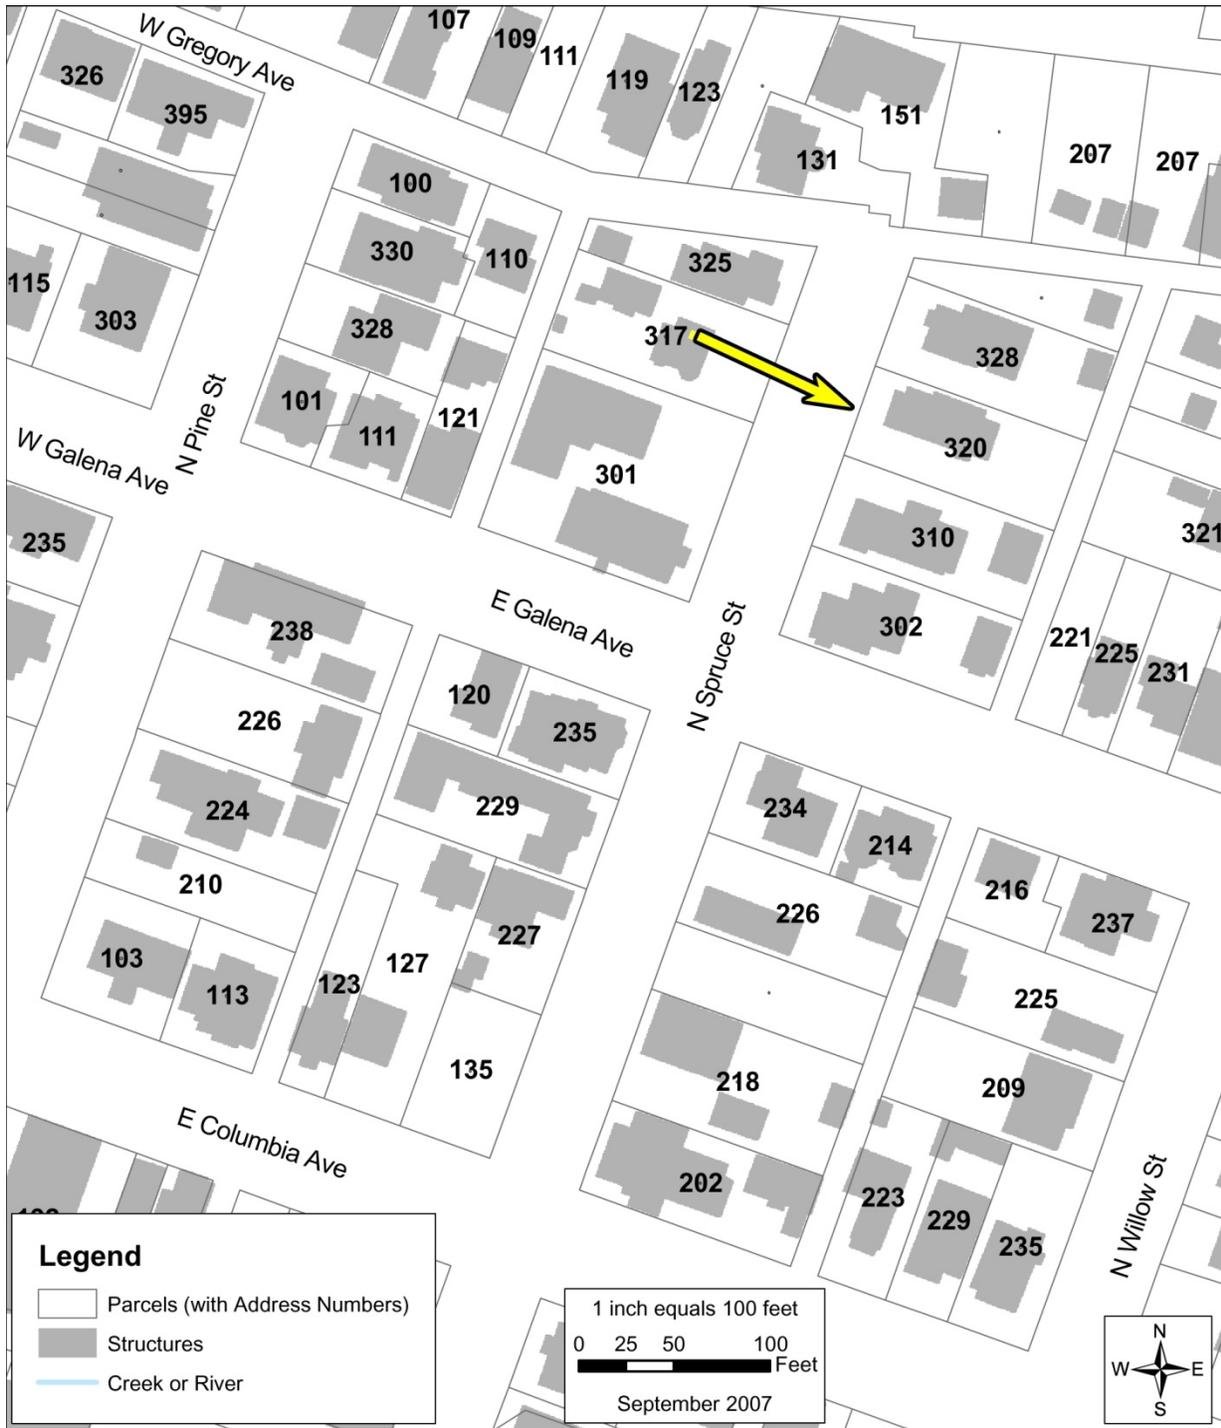
## Sketch Map

**This well-maintained property is located on the east side of Spruce Street, the second house south of Gregory Avenue, in the area of Telluride known as Catholic Hill. A planted grass front lawn, with two spruce trees, is defined by a rounded stone retaining wall. A grove of deciduous trees is south of the house. A wood privacy fence extends along the north property line.**
