COLORADO CULTURAL RESOURCE SURVEY

Architectural Inventory Form

- 1. Resource number: **5SM.1783/THAS128**
- 2. Temporary resource number: **N/A**
- 3. County: **San Miguel**
- 4. City: **Telluride**
- 5. Historic Building Name: **Munchiando House**
- 6. Current Building Name: **Geetter House**
- 7. Building Address: **229 E. Columbia Avenue**
- 8. Owner Name and Address: **Geoffrey and Carloine Scott  
12930 Morehead  
Chapel Hill, NC 27517**

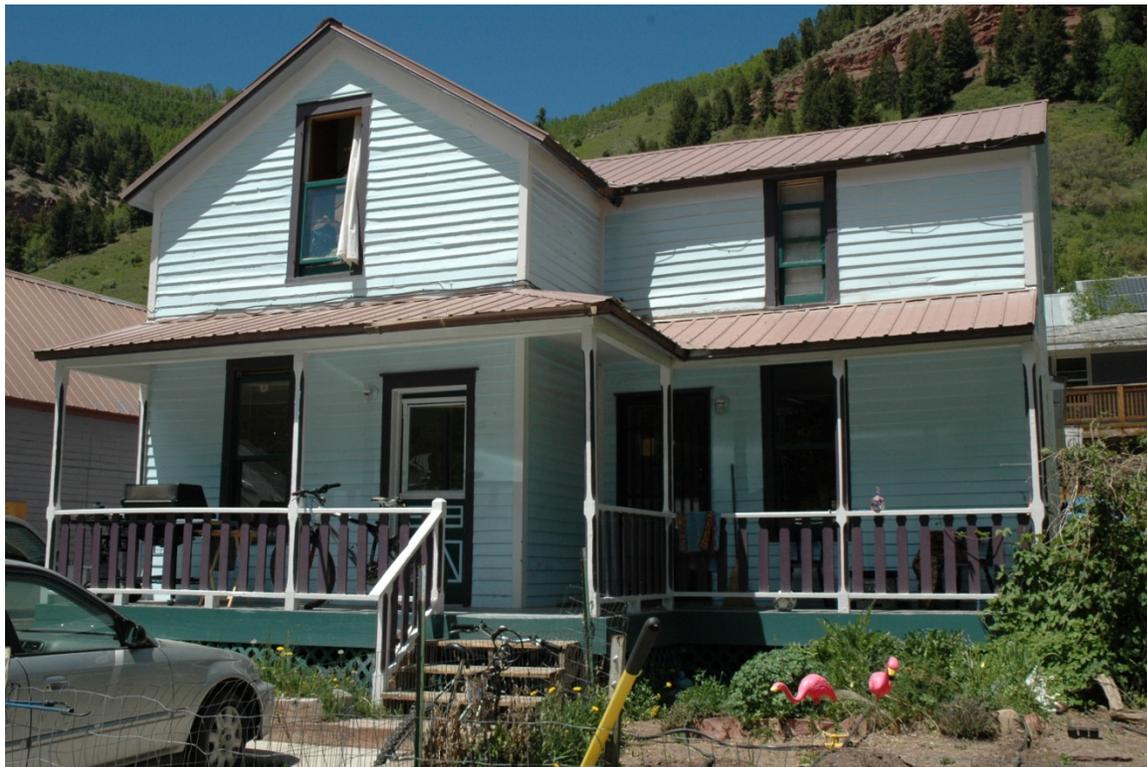
THLD RATING:

Primary - Contributing to District  
Shed - Contributing to District

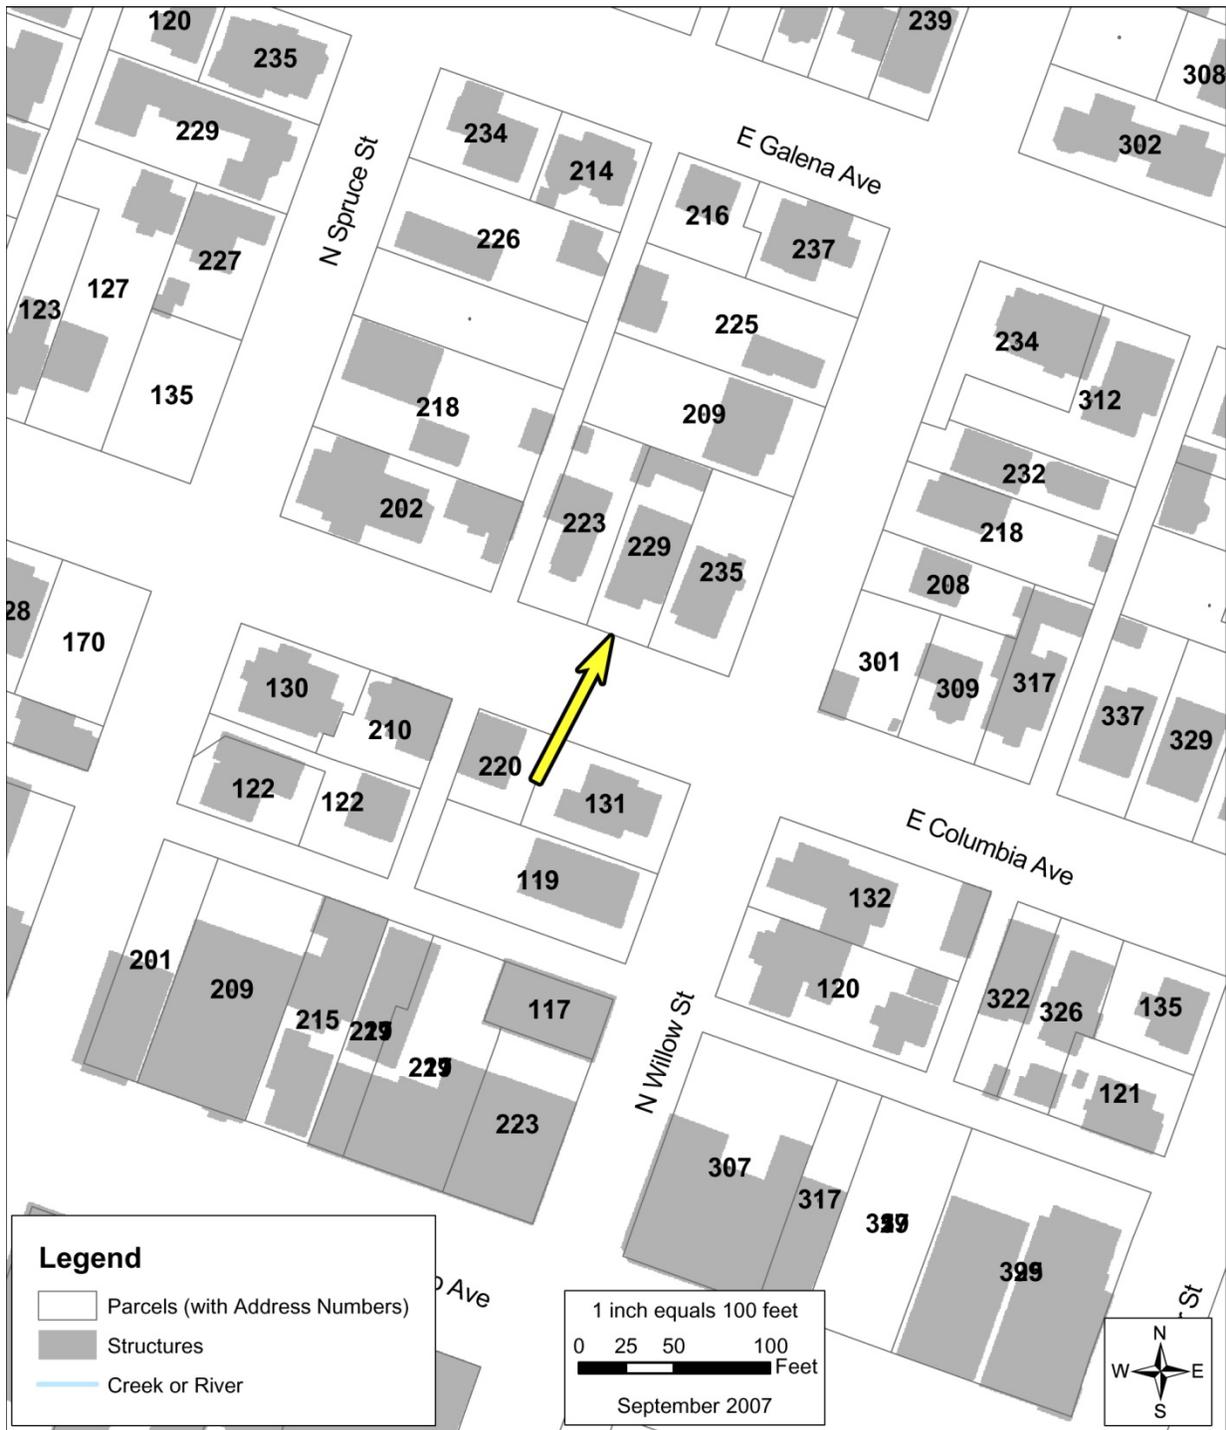
## Sketch Map

**Located on the north side of E. Columbia Avenue, this is the second property west of Willow Street. A small gravel parking lot is in front of the dwelling, while a gravel driveway extends along its west side.**
