COLORADO CULTURAL RESOURCE SURVEY

Architectural Inventory Form

- 1. Resource number: **5SM.1708**
- 2. Temporary resource number: **N/A**
- 3. County: **San Miguel**
- 4. City: **Telluride**
- 5. Historic Building Name: **Nunn House**
- 6. Current Building Name: **Friedman House**
- 7. Building Address: **409 W. Columbia Avenue**
- 8. Owner Name and Address: **Elsie D. Friedman
65 Raycliff Terrace
San Francisco, CA 94115**

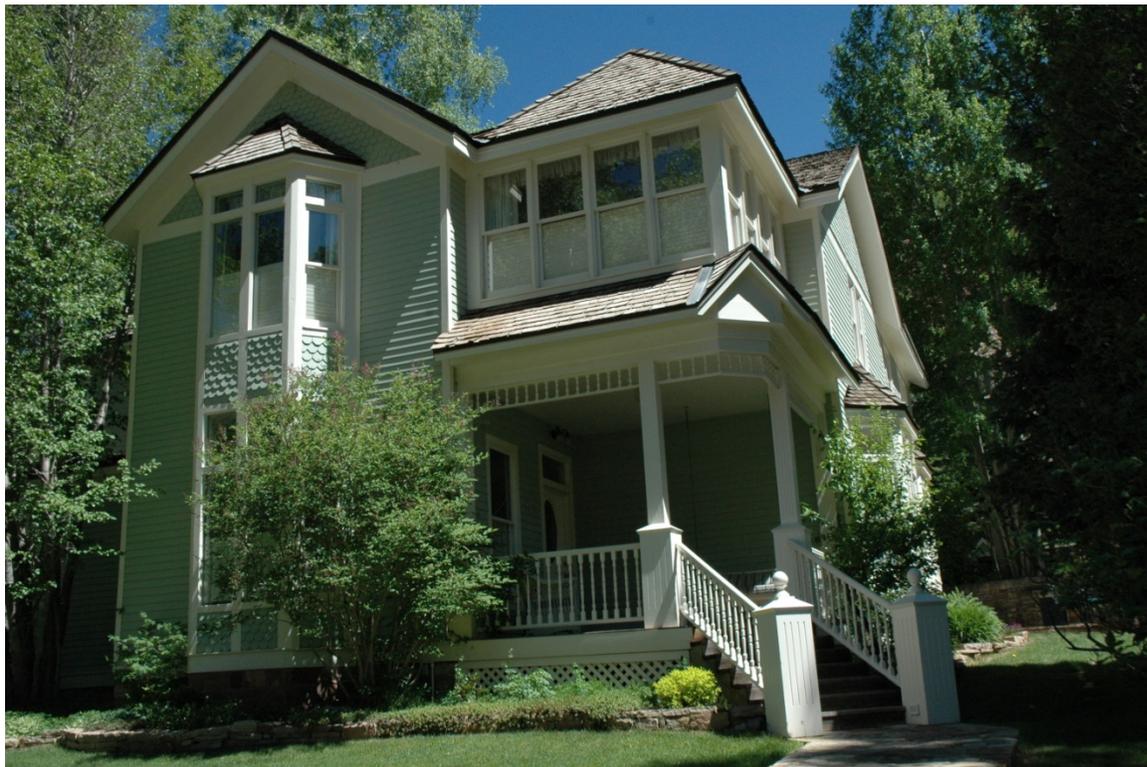
21. General architectural description:
This stately two-story dwelling is supported by a low coursed sandstone foundation, while its exterior walls are clad with painted mint green horizontal wood siding with painted white 1" by 4" corner boards. A painted mint green 1x board, with a painted white water table, separates the foundation from the siding. Painted mint green fish scale shingles appear in the upper gable ends. The house is covered by a steeply-pitched cross gable roof, with wood shingles and painted white boxed eaves. A tall red brick chimney is located on the north-facing roof slope. A painted cream white wood-paneled front door, with an oval-shaped upper sash light and a transom light, enters the south end of the east elevation from a large open front porch at the home's southeast corner. The porch is approached by seven steps, and features a wood plank floor, painted cream white fluted wood pedestals and columns, a painted cream white open wood railing with turned balusters, a painted cream white spindle frieze, and a truncated hipped roof with an intersecting gable above the porch stairs at the corner. Cannonball finials adorn twin pedestals at the base of the porch stairs. A circa 1985 second story sunroom addition, with a hipped roof and bands of 1/1 double-hung sash windows, extends above the front porch roof. A circa 1985 two-story, hipped-roof, canted bay addition, with 1/1 double-hung sash and fixed-pane windows, is located on the south elevation. A single-story canted bay and an oriel window (both circa 1985 additions), each with four 1/1 double-hung sash windows with transom lights, are located on the east elevation. A fixed-pane oculus window penetrates the second story near the north end of the east elevation. A hipped-roof bay with three 1/1 double-hung sash windows is located at the southwest corner. Windows elsewhere are primarily 1/1 double-hung sash with painted cream white wood frames and surrounds. A non-historic entry door enters the house from a flagstone patio near the north end of the east elevation. The patio at this door is covered by a flat roof with an
