COLORADO CULTURAL RESOURCE SURVEY

Architectural Inventory Form

- 1. Resource number: **5SM.1849/THAS.56**
- 2. Temporary resource number: **N/A**
- 3. County: **San Miguel**
- 4. City: **Telluride**
- 5. Historic Building Name: **Hogg House**
- 6. Current Building Name: **Smith House**
- 7. Building Address: **451 W. Galena Avenue**
- . Owner Name and Address: **Thomas D. And Melinda P. Smith
P. O. Box 266
Telluride, CO 814350266**

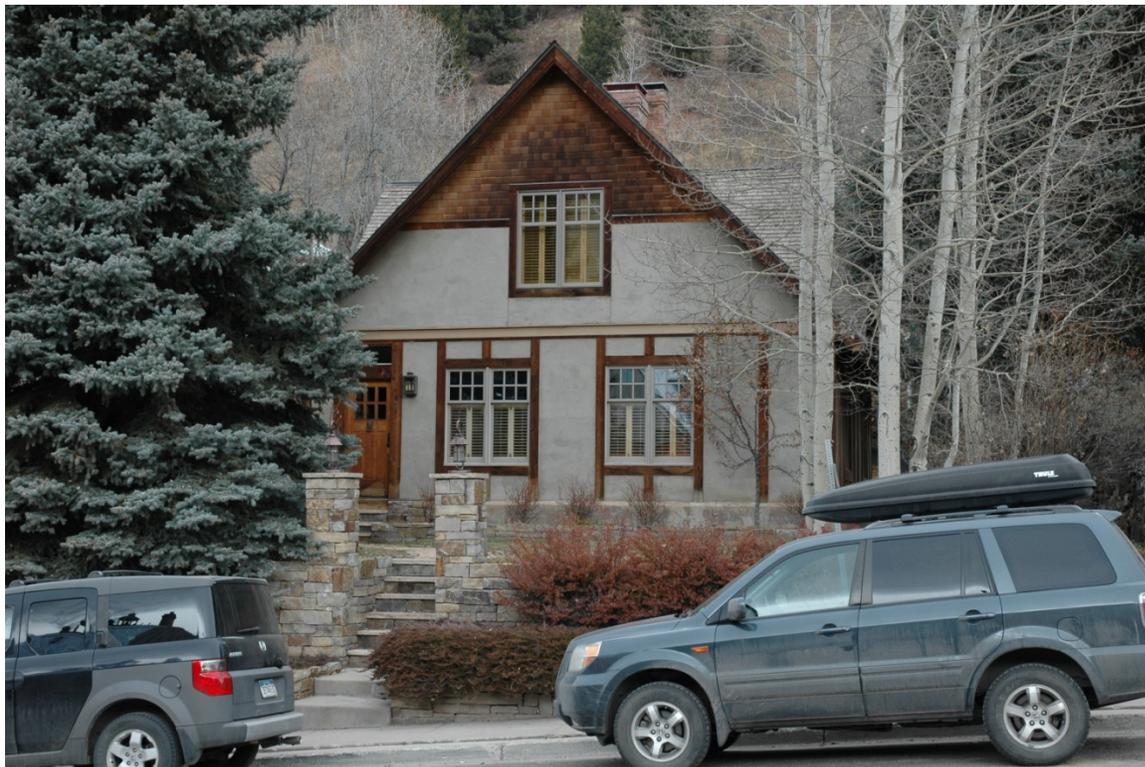
THLD RATING:	Primary - Contributing to District Shed - Contributing to District Secondary Residence/Garage – Non-Designated – New Construction
---------------------	--
