COLORADO CULTURAL RESOURCE SURVEY

Architectural Inventory Form

- Determined Eligible – National Register
- Determined Not Eligible – National Register
- Determined Eligible – State Register
- Determine Not Eligible – State Register
- Need Data
- Contributes to eligible National Register District
- Noncontributing to eligible National Register District

- 1. Resource number: **5SM.1612**
- 2. Temporary resource number: **N/A**
- 3. County: **San Miguel**
- 4. City: **Telluride**
- 5. Historic Building Name: **"Female Boardinghouse"**
- 6. Current Building Name: **Sheridan House**
- 7. Building Address: **125/27 E Pacific Ave**
- 8. Owner Name and Address: **Christian McConnell and Arguelles Jess  
P. O. Box 3767  
Telluride, CO 81435**

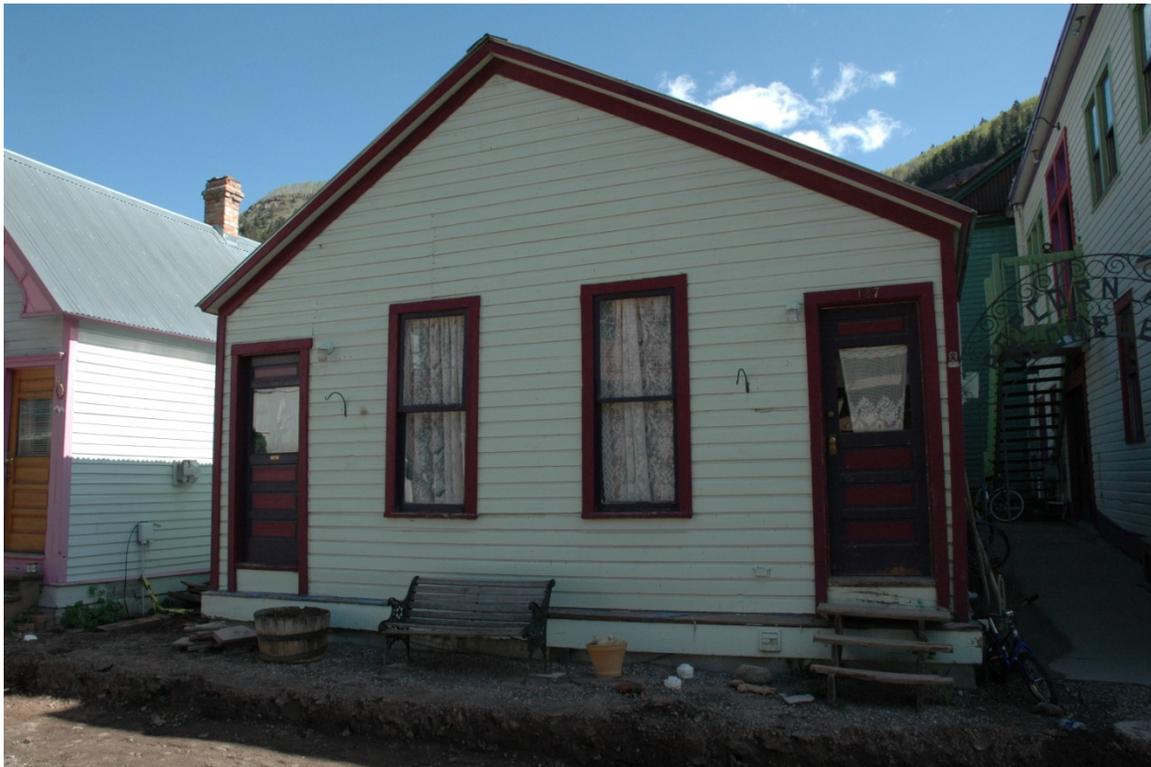
**This small wood frame dwelling features a basic rectangular plan, with a front-gabled roof. The façade is set back approximately four feet from the concrete sidewalk which parallels Pacific Avenue on the south elevation. The building is supported by a non-historic concrete foundation, with a single-light basement window penetrating the foundation wall on the west elevation. The exterior walls are clad with painted green horizontal weatherboard siding, or board-and-batten, with painted burgundy color 1" by 4" corner boards. The front gabled roof is moderately-pitched, and is covered with metal roofing material. The eaves are boxed with painted burgundy and green wood trim, and two red brick chimneys with corbelled caps are located on the ridge. Two, painted purple with red trim, wood-paneled doors respectively enter either end of the façade. Each of these doors has an upper sash light. Two 1/1 double-hung sash windows, with painted purple wood frames and painted burgundy wood surrounds, penetrate the façade wall between the two doors. Wood-paneled doors are also located at either end of the north (rear) elevation.**

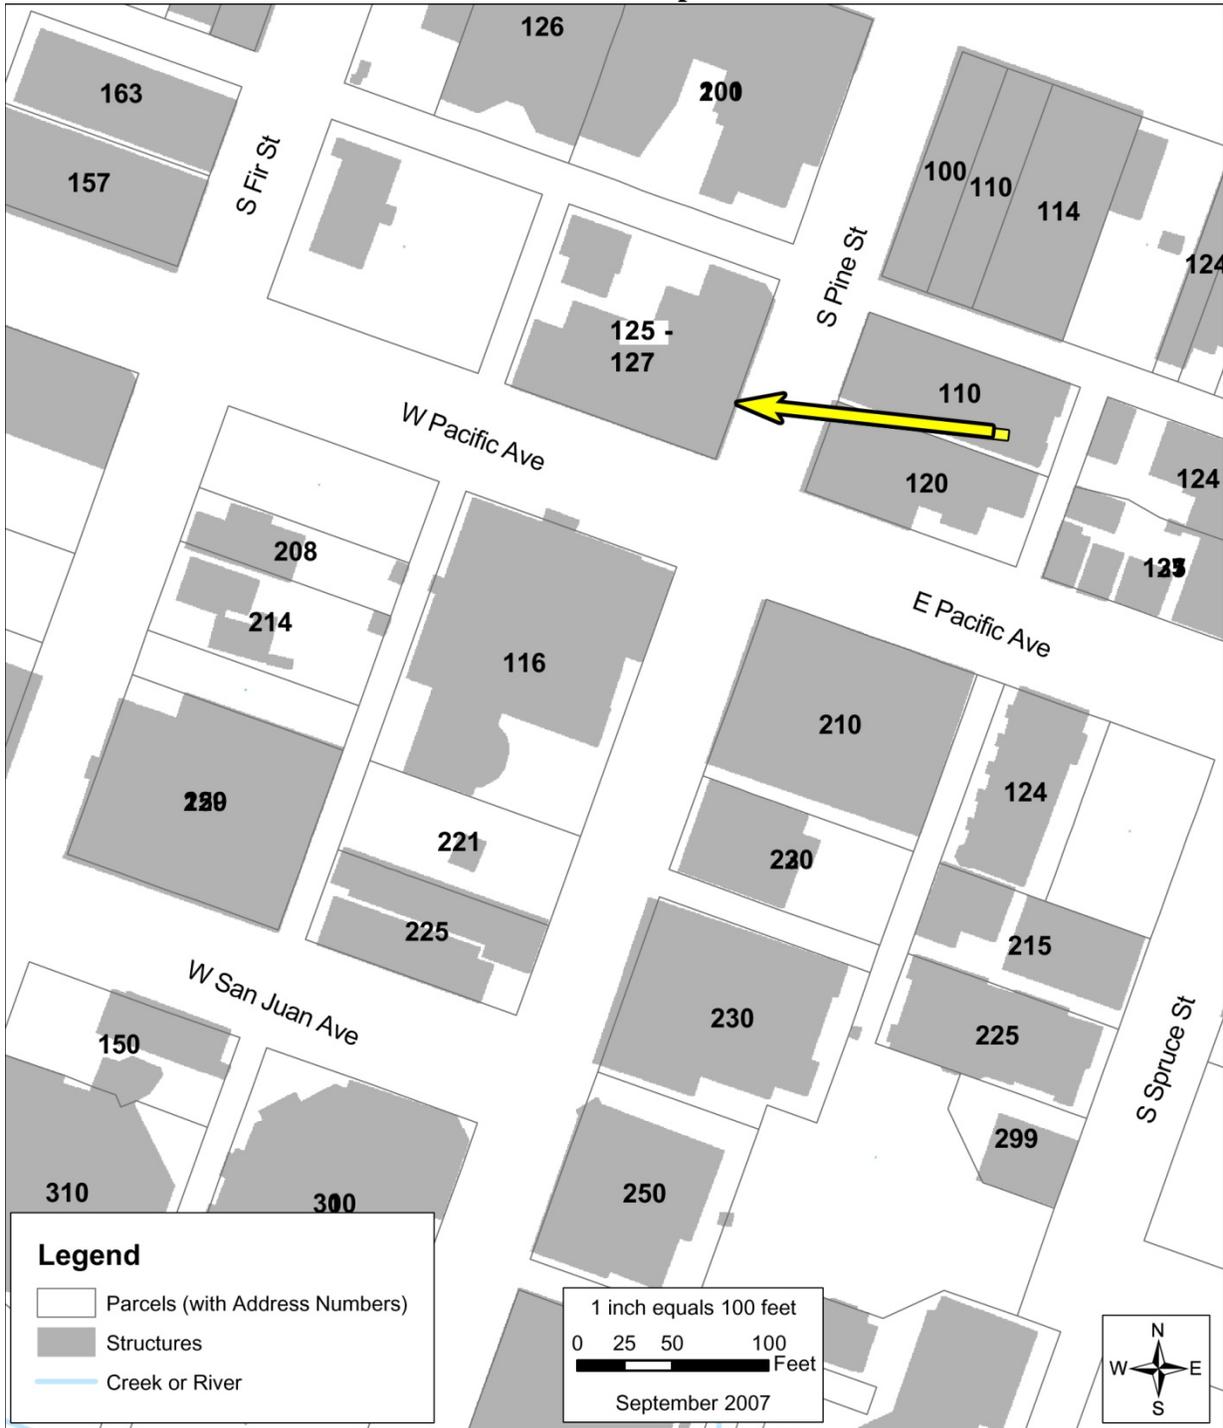
## Sketch Map

22. Architectural style: **No Defined Style**  
 Building type:
23. Landscape or special setting features: **This small building, and other similar related buildings, are located on the north side of Pacific Avenue, in the block between Spruce and Pine Streets. The Silver Bell building is located immediately to the east of this building at the northwest corner of Spruce Street and Pacific Avenue. A small yard, shared with 121, 121 1/2, and 123 E. Pacific Avenue is located behind the building to the north.**

<p><b>Privy</b></p> <p>A small building (historically a two-hole privy) is located in the yard behind the house. Measuring approximately 4' by 6', the privy has a concrete slab foundation and floor, and painted cream yellow horizontal weatherboard walls with painted purple 1" by 4" corner boards. It is covered by a side-gable roof covered with green asphalt composition shingles. The eaves are boxed with painted purple and cream yellow wood trim. Two painted cream yellow wood-paneled doors are located on the south elevation.</p>
-------------------------------------------------------------------------------------------------------------------------------------------------------------------------------------------------------------------------------------------------------------------------------------------------------------------------------------------------------------------------------------------------------------------------------------------------------------------------------------------------------------------------------------------------------
